# Access Compliance Report

## Public Rights-of-Way

### (Curb Ramps)

| Intersection ID: 53397 | Main Street: AGNEW_DR | Cross Street: PAMPLIN_CT | Location: SW |

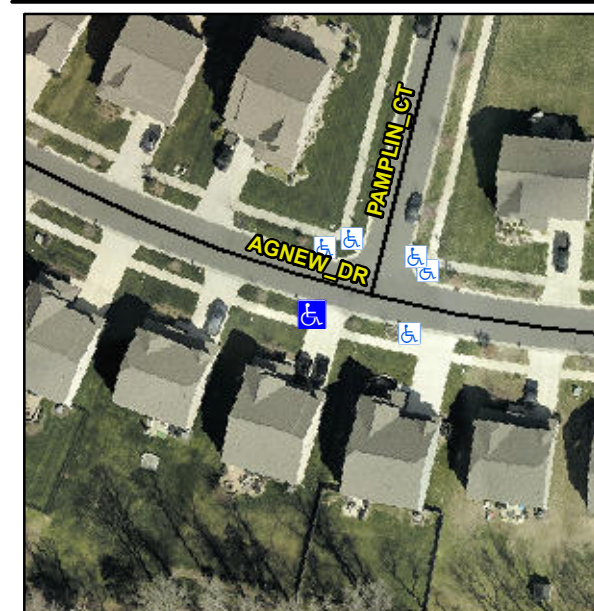
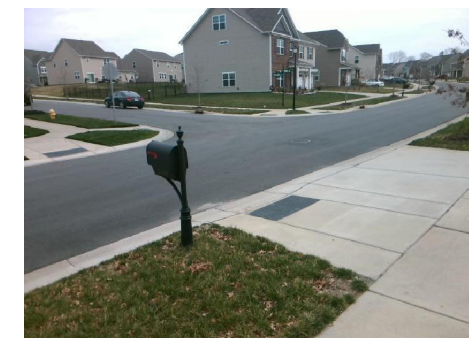
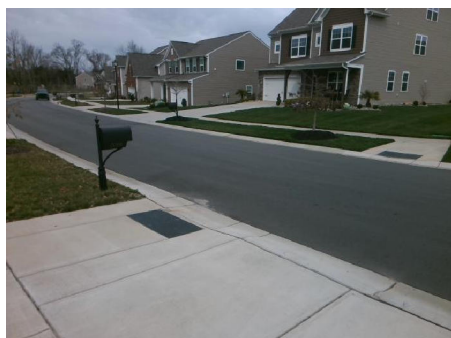
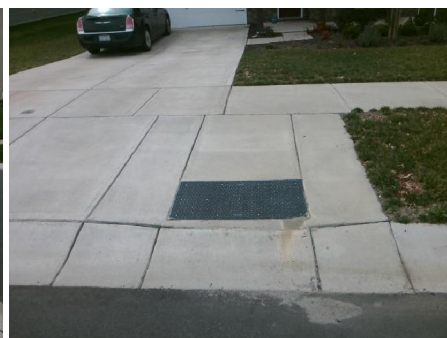
| ADA ID: 6F8BFC8F233B | Ramp Type: Perp | Initial Pass/Fail: Fail | Overall Compliance: No |

**Not Found, R304.5.1, R304.5.3**

| Compliance | Description | Data | Compliance | Description | Data |
|---|---|---|---|---|---|
| N/A | Ramp Length (in) | 96.0 | Yes | Ramp Slope (%) | 6.3 |
| No | Ramp Width (in) | 47.0 | No | Ramp XSlope (%) | 3.0 |

**Remove & Replace Entire Ramp.**
