# Access Compliance Report

## Public Rights-of-Way

### (Curb Ramps)

| Intersection ID: 43842 | Main Street: BRADSTREET_COMMONS_WY | Cross Street: DELUCA_DR | Location: NE |

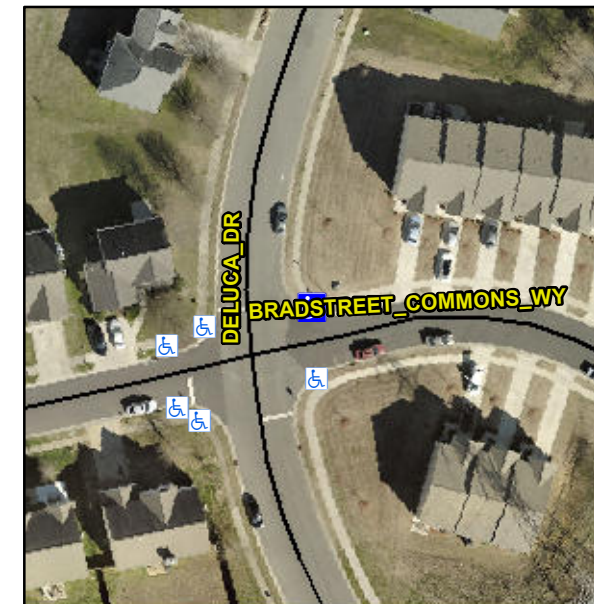
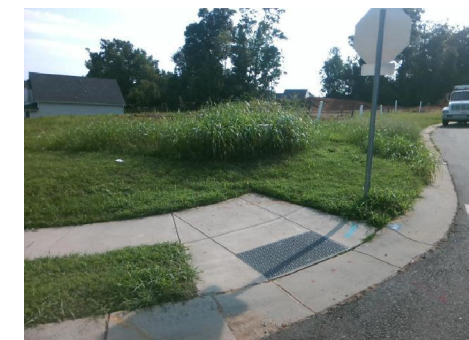
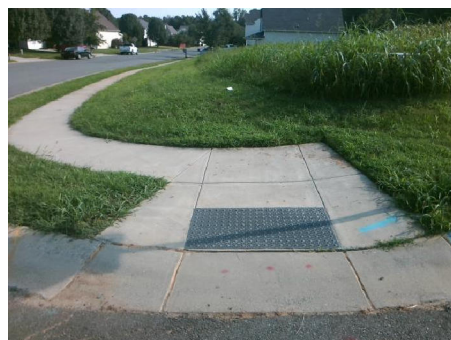
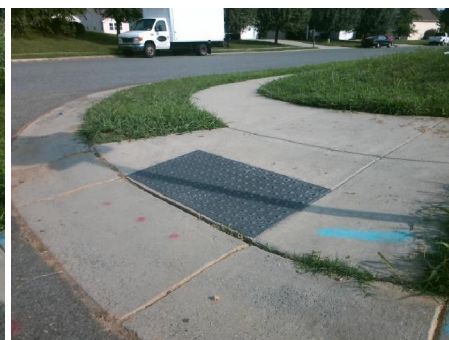
| ADA ID: 6FA5E7CEC99C | Ramp Type: PerpDiag | Initial Pass/Fail: Fail | Overall Compliance: No |

**Not Found, R304.5.1, R304.5.3**

| Compliance | Description | Data | Compliance | Description | Data |
|---|---|---|---|---|---|
| N/A | Ramp Length (in) | 47.5 | Yes | Ramp Slope (%) | 7.1 |
| No | Ramp Width (in) | 47.0 | No | Ramp XSlope (%) | 4.3 |

**Remove & Replace Curb Ramp With Two New Directional Ramps or Equivalent.**

Total Cost: \$ 3200.00
