Access Compliance Report

Public Rights-of-Way

(Curb Ramps)

Intersection ID: 10021845	Main Street: BRIXHAM_HILL_AV	Cross Street: N/A	Location: NW
ADA ID: 6FAA81816F06	Ramp Type: Perp	Initial Pass/Fail: Fail	Overall Compliance: No
		Severity Score: 1.25

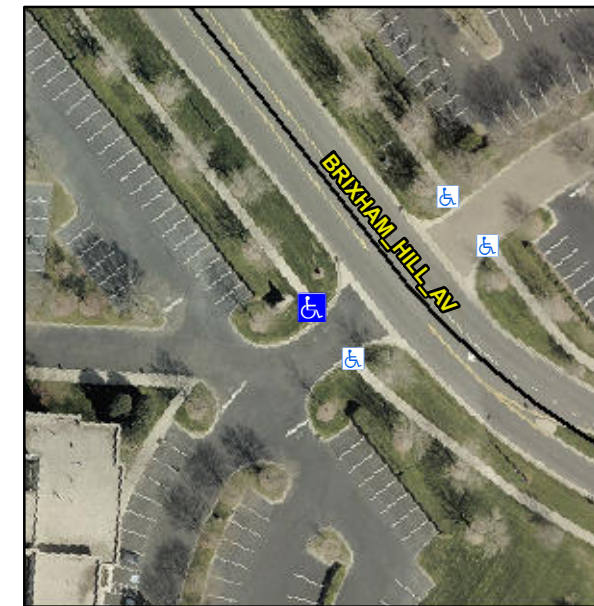
Not Found, R304.5.3

Compliance	Description	Data	Compliance	Description	Data
N/A	Ramp Length (in)	71.0	Yes	Ramp Slope (%)	5.3
Yes	Ramp Width (in)	58.0	No	Ramp XSlope (%)	2.4
N/A	Flare Type LT	N/A	N/A	Flare Type RT	N/A
N/A	Flare Slope LT (%)	N/A	N/A	Flare Slope RT (%)	N/A
N/A	Flare Traversable LT?	N/A	N/A	Flare Traversable RT?	N/A
N/A	Landing Length (in)	N/A	N/A	DWS Provided?	N/A
N/A	Landing Width (in)	N/A	N/A	DWS Contrast?	N/A
N/A	Landing Slope (%)	N/A	N/A	DWS Length (in)	N/A
N/A	Landing X Slope (%)	N/A	N/A	DWS Full Width?	N/A
N/A	Landing Curb? (Y/N)	N/A	N/A	DWS Offset (in)	N/A
N/A	Shared Landing?	N/A			
N/A	Gutter Ponding?	N/A	N/A	Gutter Slope (%)	N/A
N/A	Gutter Lip Ht (in)	N/A	N/A	Gutter X Slope (%)	N/A
N/A	Painted X Walk1?	No	N/A	Painted X Walk2?	N/A
	X Walk 1 Direction	To SE		X Walk 2 Direction	N/A
N/A	X Walk 1 Width (in)	N/A	N/A	X Walk 2 Width (in)	N/A
	X Walk 1 Slope (%)	9.5		X Walk 2 Slope (%)	N/A
	X Walk 1 X Slope (%)	0.3		X Walk 2 X Slope (%)	N/A

N/A	Ramp inside XWalk1?	N/A	N/A	Ramp inside XWalk2?	N/A
	Road Slope (%)	N/A	N/A	Clear Space?	N/A
	Road X Slope (%)	N/A	N/A	Clear Space to XWalk (in)	N/A
N/A	Any Obstructions?	N/A	N/A	Storm Grate/Utility Hazard?	N/A
	Obstruction Type			Storm Grate/Utility Type	
		N/A			N/A
		Yes		Surface Condition? (G/P)	Good

Remove & Replace Entire Ramp.

Total Cost: \$ 1850.00
