Access Compliance Report

Public Rights-of-Way

(Curb Ramps)

Intersection ID: 44107	Main Street: STAFFORDSHIRE_LN	Cross Street: CALDWELL_RD	Location:	N
ADA ID: 6FBDC19A535E	Ramp Type: Perp	Initial Pass/Fail: Fail	Overall Compliance: No	Severity Score: 21.25
Codes/Mitigation Info/Possible Solution		Field Measurements/Component Compliance

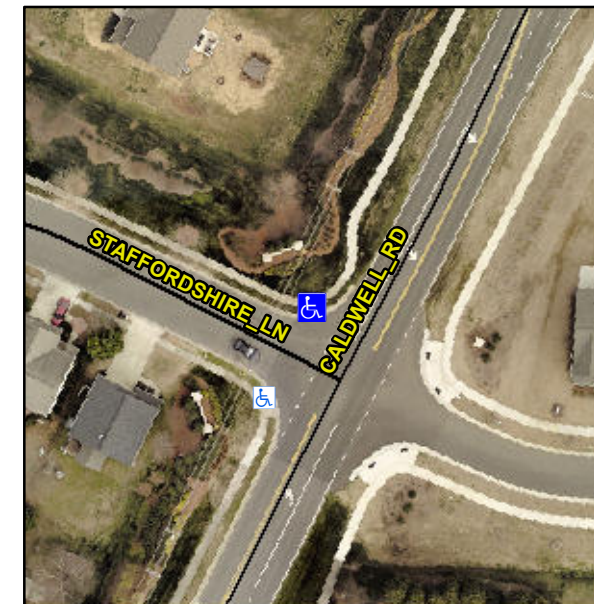
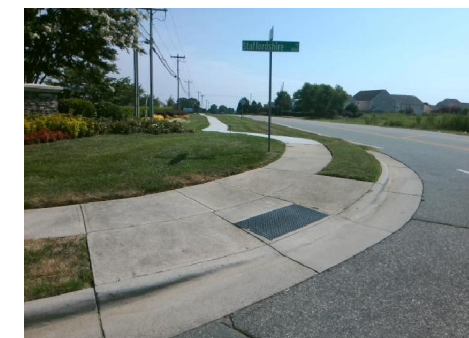
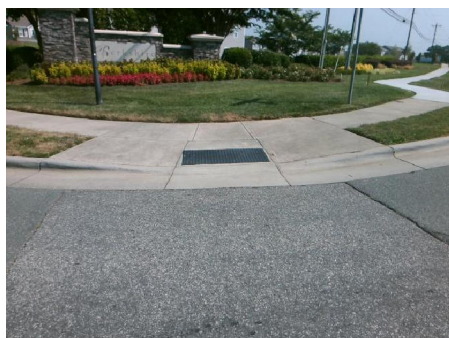
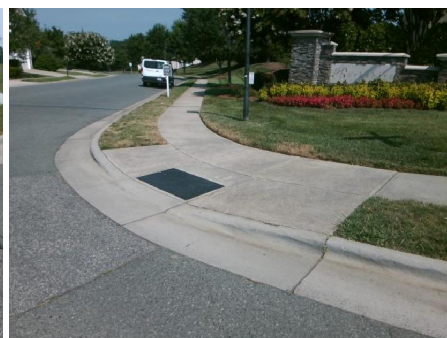
Not Found, R304.5.1, R304.5.3

Compliance	Description	Data	Compliance	Description	Data
N/A	Ramp Length (in)	47.0	Yes	Ramp Slope (%)	6.1
No	Ramp Width (in)	45.0	No	Ramp XSlope (%)	5.1
N/A	Flare Type LT	N/A	N/A	Flare Type RT	N/A
N/A	Flare Slope LT (%)	N/A	N/A	Flare Slope RT (%)	N/A
N/A	Flare Traversable LT?	N/A	N/A	Flare Traversable RT?	N/A
N/A	Landing Length (in)	N/A	N/A	DWS Provided?	N/A
N/A	Landing Width (in)	N/A	N/A	DWS Contrast?	N/A
N/A	Landing Slope (%)	N/A	N/A	DWS Length (in)	N/A
N/A	Landing X Slope (%)	N/A	N/A	DWS Full Width?	N/A
N/A	Landing Curb? (Y/N)	N/A	N/A	DWS Offset (in)	N/A
N/A	Shared Landing?	N/A			
N/A	Gutter Ponding?	N/A	N/A	Gutter Slope (%)	N/A
N/A	Gutter Lip Ht (in)	N/A	N/A	Gutter X Slope (%)	N/A
N/A	Painted X Walk1?	No	N/A	Painted X Walk2?	N/A
	X Walk 1 Direction	To W		X Walk 2 Direction	N/A
N/A	X Walk 1 Width (in)	N/A	N/A	X Walk 2 Width (in)	N/A
	X Walk 1 Slope (%)	0.9		X Walk 2 Slope (%)	N/A
	X Walk 1 X Slope (%)	5.5		X Walk 2 X Slope (%)	N/A

N/A	Ramp inside XWalk1?	N/A	N/A	Ramp inside XWalk2?	N/A
	Road Slope (%)	N/A	N/A	Clear Space?	N/A
	Road X Slope (%)	N/A	N/A	Clear Space to XWalk (in)	N/A
N/A	Any Obstructions?	N/A	N/A	Storm Grate/Utility Hazard?	N/A
	Obstruction Type			Storm Grate/Utility Type	
		N/A			N/A
			Yes	Surface Condition? (G/P)	Good

Remove & Replace Entire Ramp.
