Access Compliance Report

Public Rights-of-Way

(Curb Ramps)

Intersection ID: 31313	Main Street: DEERTON_RD	Cross Street: EBEN_DR	Location:	N
ADA ID: 6FC21AF78B68	Ramp Type: PerpDiag	Initial Pass/Fail: Fail	Overall Compliance: No	Severity Score: 12.5
Codes/Mitigation Info/Possible Solution		Field Measurements/Component Compliance

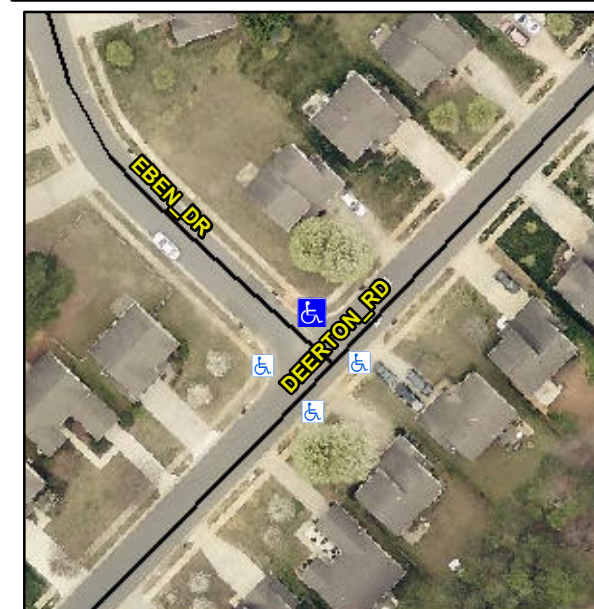
PROW/ADA:

Not Found, R304.2.2

Compliance	Description	Data	Compliance	Description	Data
N/A	Ramp Length (in)	50.5	No	Ramp Slope (%)	10.6
Yes	Ramp Width (in)	48.0	Yes	Ramp XSlope (%)	0.0
N/A	Flare Type LT	N/A	N/A	Flare Type RT	N/A
N/A	Flare Slope LT (%)	N/A	N/A	Flare Slope RT (%)	N/A
N/A	Flare Traversable LT?	N/A	N/A	Flare Traversable RT?	N/A
N/A	Landing Length (in)	N/A	N/A	DWS Provided?	N/A
N/A	Landing Width (in)	N/A	N/A	DWS Contrast?	N/A
N/A	Landing Slope (%)	N/A	N/A	DWS Length (in)	N/A
N/A	Landing X Slope (%)	N/A	N/A	DWS Full Width?	N/A
N/A	Landing Curb? (Y/N)	N/A	N/A	DWS Offset (in)	N/A
N/A	Shared Landing?	N/A			
N/A	Gutter Ponding?	N/A	N/A	Gutter Slope (%)	N/A
N/A	Gutter Lip Ht (in)	N/A	N/A	Gutter X Slope (%)	N/A
N/A	Painted X Walk1?	No	N/A	Painted X Walk2?	No
	X Walk 1 Direction	To SW		X Walk 2 Direction	To SE
N/A	X Walk 1 Width (in)	N/A	N/A	X Walk 2 Width (in)	N/A
	X Walk 1 Slope (%)	2.7		X Walk 2 Slope (%)	0.5
	X Walk 1 X Slope (%)	0.6		X Walk 2 X Slope (%)	0.5

N/A	Ramp inside XWalk1?	N/A	N/A	Ramp inside XWalk2?	N/A
	Road Slope (%)	0.1	N/A	Clear Space?	N/A
	Road X Slope (%)	2.2	N/A	Clear Space to XWalk (in)	N/A
N/A	Any Obstructions?	N/A	N/A	Storm Grate/Utility Hazard?	N/A
	Obstruction Type			Storm Grate/Utility Type	
		N/A			N/A
			Yes	Surface Condition? (G/P)	Good

Possible Solutions:

Remove & Replace Curb Ramp With Two New Directional Ramps or Equivalent.
