Access Compliance Report Public Rights-of-Way (Curb Ramps)

Intersection ID: 14193 Main Street: E_5TH_ST Cross Street: N_CASWELL_RD Location: SW

ADA ID: 6FD2C29896D9 Ramp Type: Directional1 Initial Pass/Fail: Fail Overall Compliance: No Severity Score: 12.5

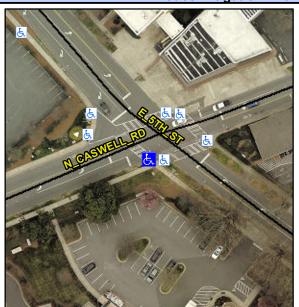
Possible Solution		Field Measurements/Component Compliance								
Possible Solutions:			Comp	oliance	Description	Data	Compli	ance	Description	
Remove & Replace Entire Ramp.		np.	N/A	Ram	p Length (in)	54.0	N/A	Grade	e Break?

•	Yes	Ram	p Width (in)	48.0	N/A	Grade	e Break Slope (%)		
			No	Ram	p Slope (%)	8.6	N/A	Grade	e Break XSlope (%)	
			Yes	Ram	p XSlope (%)	1.8				
			N/A	Flare	Type LT	N/A	N/A	Flare	Type RT	
			N/A	Flare	Slope LT (%)	N/A	N/A	Flare	Slope RT (%)	
Surveyor Notes:			N/A	Flare	Traversable LT?	N/A	N/A	Flare	Traversable RT?	
N/A			N/A	Land	ing Length (in)	0.0	N/A	DWS	Provided?	
			N/A	Land	ing Width (in)	0.0	N/A	DWS	Contrast?	
			N/A	Land	ing Slope (%)	0.0	N/A	DWS	Length (in)	
			N/A	Land	ing X Slope (%)	0.0	N/A	DWS	Full Width?	
PROW/ADA:			N/A	Land	ing Curb? (Y/N)	N/A	N/A	DWS	Offset LT (in)	
R304.2.2			N/A	Share	ed Landing?	N/A	N/A	DWS	Offset RT (in)	
			N/A	Gutte	er Ponding?	0.0	N/A	Gutte	r Slope (%)	
			N/A	Gutte	er Lip Ht (in)	0.0	N/A	Gutte	r X Slope (%)	
			N/A	Paint	ed X Walk1?	Yes		Road	Slope (%)	
				X Wa	lk 1 Direction	To NW		Road	X Slope (%)	
				X Wa	ılk 1 Width (in)	106.0		Clear	Space?	
				X Wa	ılk 1 Slope (%)	3.0	N/A	Clear	Space to XWalk (in)

X Wa	ılk 1 X Slope (%)	1.9	N/A	Storm	n Grate/Utility Hazard?	
		N/A	Ram	p inside XWalk1?	Yes		Storm	n Grate/Utility Type		
			N/A	Any (Obstructions?	N/A				
Total Cost:	\$	1600.00		Obst	ruction Type		Yes	Surfa	ce Condition? (G/P)	
						N/A	N/A	Curb	Slope (%)
