Access Compliance Report

Public Rights-of-Way

(Curb Ramps)

| Intersection ID: 43869 | Main Street: CALDWELL_RIDGE_PY | Cross Street: SIDNEY_CREST_AV | Location: SE |

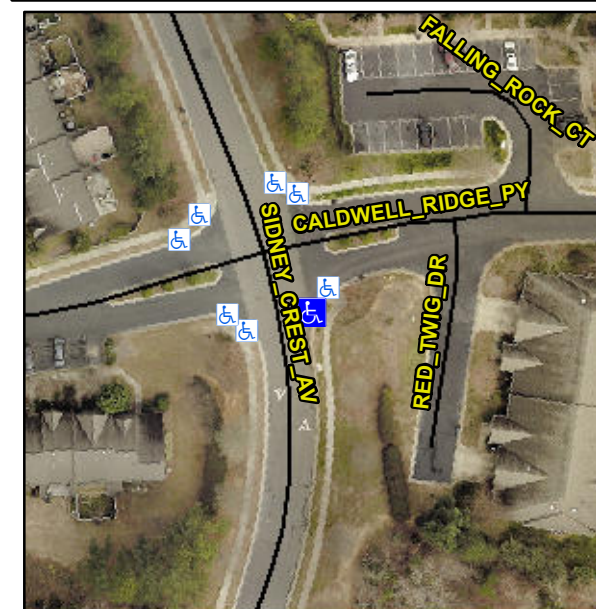
| ADA ID: 6FD48E16C03E | Ramp Type: Perp | Initial Pass/Fail: Fail | Overall Compliance: No |
| Severity Score: 10 | | | |

Not Found, R304.5.1, R304.5.3

| Compliance | Description | Data | Compliance | Description | Data |
|---|---|---|---|---|---|
| N/A | Ramp Length (in) | 50.0 | Yes | Ramp Slope (%) | 7.6 |
| No | Ramp Width (in) | 42.5 | No | Ramp XSlope (%) | 2.3 |

Possible Solutions:

Remove & Replace Entire Ramp.

Total Cost: \$ 1850.00
