Access Compliance Report

Public Rights-of-Way

(Curb Ramps)

Intersection ID: 21478	Main Street: KILCULLEN_DR	Cross Street: N/A	Location: NW
ADA ID: 6FE5C492D1A5	Ramp Type: PerpDiag	Initial Pass/Fail: Fail	Overall Compliance: No
		Severity Score: 25

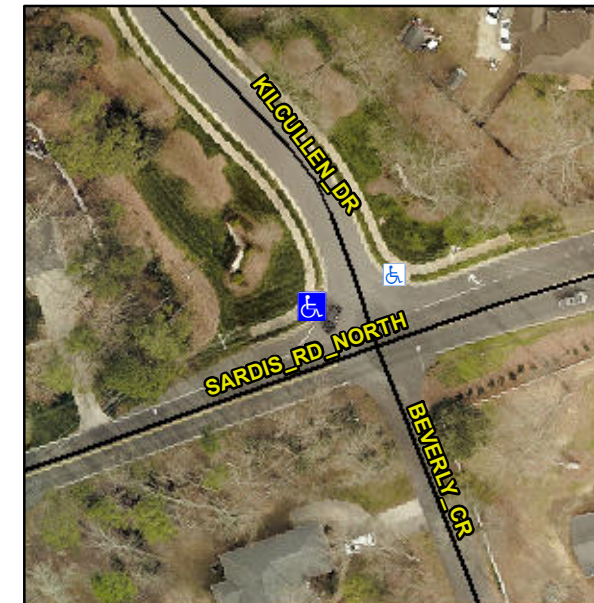
Not Found, R304.5.3

Compliance	Description	Data	Compliance	Description	Data
N/A	Ramp Length (in)	48.0	Yes	Ramp Slope (%)	7.4
Yes	Ramp Width (in)	48.0	No	Ramp XSlope (%)	8.0
N/A	Flare Type LT	N/A	N/A	Flare Type RT	N/A
N/A	Flare Slope LT (%)	N/A	N/A	Flare Slope RT (%)	N/A
N/A	Flare Traversable LT?	N/A	N/A	Flare Traversable RT?	N/A
N/A	Landing Length (in)	N/A	N/A	DWS Provided?	N/A
N/A	Landing Width (in)	N/A	N/A	DWS Contrast?	N/A
N/A	Landing Slope (%)	N/A	N/A	DWS Length (in)	N/A
N/A	Landing X Slope (%)	N/A	N/A	DWS Full Width?	N/A
N/A	Landing Curb? (Y/N)	N/A	N/A	DWS Offset (in)	N/A
N/A	Shared Landing?	N/A			
N/A	Gutter Ponding?	N/A	N/A	Gutter Slope (%)	N/A
N/A	Gutter Lip Ht (in)	N/A	N/A	Gutter X Slope (%)	N/A
N/A	Painted X Walk1?	No	N/A	Painted X Walk2?	No
	X Walk 1 Direction	To S		X Walk 2 Direction	To E
N/A	X Walk 1 Width (in)	N/A	N/A	X Walk 2 Width (in)	N/A
	X Walk 1 Slope (%)	1.4		X Walk 2 Slope (%)	5.8
	X Walk 1 X Slope (%)	5.2		X Walk 2 X Slope (%)	1.0

N/A	Ramp inside XWalk1?	N/A	N/A	Ramp inside XWalk2?	N/A
	Road Slope (%)	4.3	N/A	Clear Space?	N/A
	Road X Slope (%)	3.1	N/A	Clear Space to XWalk (in)	N/A
N/A	Any Obstructions?	N/A	N/A	Storm Grate/Utility Hazard?	N/A
	Obstruction Type			Storm Grate/Utility Type	
		N/A			N/A
			Yes	Surface Condition? (G/P)	Good

Remove & Replace Curb Ramp With Two New Directional Ramps or Equivalent.

Total Cost: \$ 3200.00
