Access Compliance Report Public Rights-of-Way (Curb Ramps)

Intersection ID: 10028419 Main Street: HIGHGROVE ST Cross Street: N/A Location: NE Initial Pass/Fail: Fail **Overall Compliance: No ADA ID: 6FF4482BF3C8** Ramp Type: PerpDiag Severity Score: 33.75

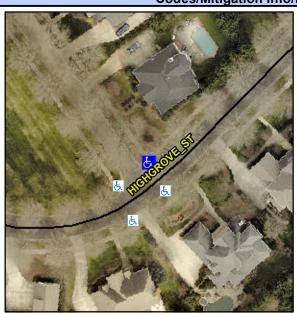
Not Found, R304.5.1, R304.2.2, R304.5.3

Total Cost: 3200.00 Compliance Description Data Compliance Description Data No N/A Ramp Length (in) 101.0 Ramp Slope (%) 11.4 No No Ramp Width (in) 47.0 Ramp XSlope (%) 5.7 N/A N/A Flare Type LT N/A Flare Type RT N/A N/A N/A N/A Flare Slope RT (%) N/A Flare Slope LT (%) N/A Flare Traversable LT? N/A N/A Flare Traversable RT? N/A N/A N/A N/A **DWS Provided?** N/A Landing Length (in) N/A Landing Width (in) N/A N/A **DWS Contrast?** N/A N/A N/A N/A Landing Slope (%) DWS Length (in) N/A N/A Landing X Slope (%) N/A N/A DWS Full Width? N/A N/A Landing Curb? (Y/N) N/A N/A DWS Offset (in) N/A N/A N/A Shared Landing? N/A **Gutter Ponding?** N/A N/A Gutter Slope (%) N/A N/A Gutter Lip Ht (in) N/A N/A Gutter X Slope (%) N/A N/A Painted X Walk1? No N/A Painted X Walk2? No X Walk 1 Direction To SW X Walk 2 Direction To S N/A N/A X Walk 1 Width (in) X Walk 2 Width (in) N/A X Walk 1 Slope (%) 2.9 X Walk 2 Slope (%) 5.7 X Walk 1 X Slope (%) 0.3 X Walk 2 X Slope (%) 3.0 N/A N/A N/A Ramp inside XWalk2? N/A Ramp inside XWalk1? Road Slope (%) 3.3 N/A Clear Space? N/A N/A Road X Slope (%) Clear Space to XWalk (in) N/A 4.0 N/A N/A N/A Any Obstructions? Storm Grate/Utility Hazard? N/A **Obstruction Type** Storm Grate/Utility Type N/A N/A

Possible Solutions: Remove & Replace Curb Ramp With Two New Directional Ramps or Equivalent. Surveyor Notes: N/A PROW/ADA:
