Access Compliance Report

Public Rights-of-Way

| Intersection ID: 19575 | Main Street: SARDIS_RD | Cross Street: STRAWBERRY_HILL_DR | Location: W |
| ADA ID: 6FFB7895B2F9 | Ramp Type: PerpDiag | Initial Pass/Fail: Fail | Overall Compliance: No |

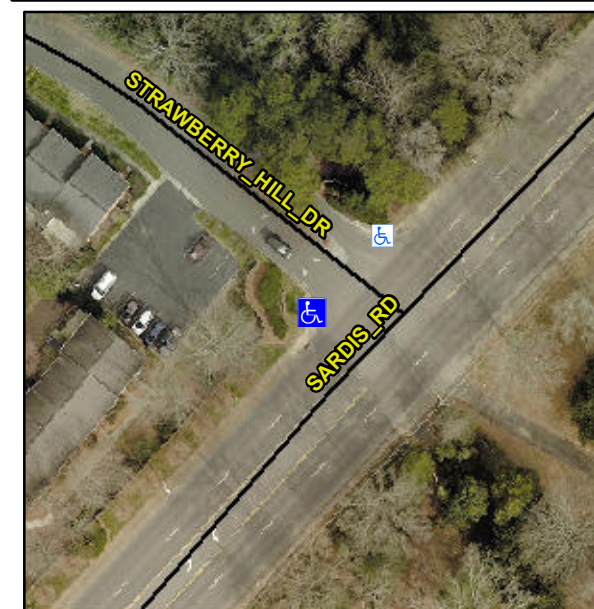
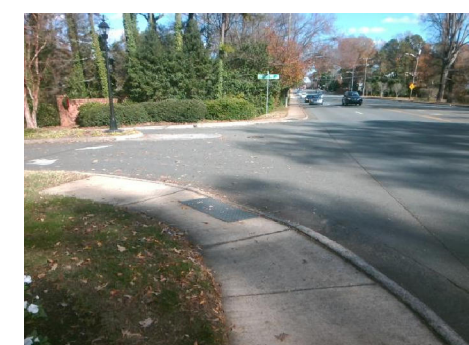
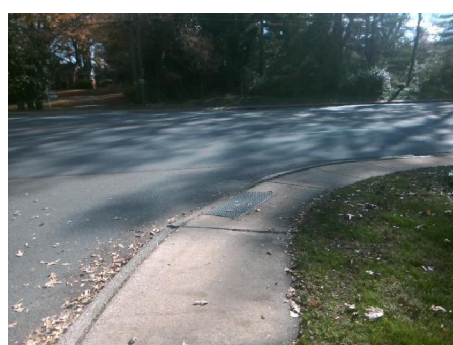
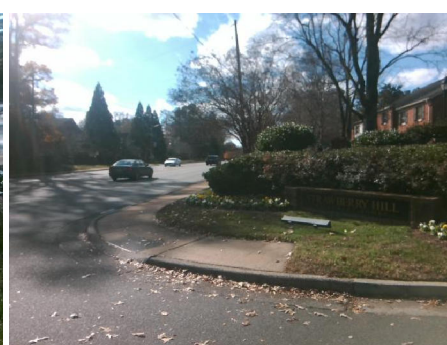
Not Found, R304.2.2

| Compliance | Description | Data | Compliance | Description | Data |
|---|---|---|---|---|---|
| N/A | Ramp Length (in) | 58.0 | No | Ramp Slope (%) | 11.7 |
| Yes | Ramp Width (in) | 48.0 | Yes | Ramp XSlope (%) | 0.4 |

Remove & Replace Curb Ramp With Two New Directional Ramps or Equivalent.
