Access Compliance Report Public Rights-of-Way (Curb Ramps)

Intersection ID: 7195 Main Street: REAGAN DR **Cross Street: TOM HUNTER RD** Location: SW **Overall Compliance: No** Severity Score: 46.25 ADA ID: 70111C004680 Ramp Type: Combination1 Initial Pass/Fail: Fail

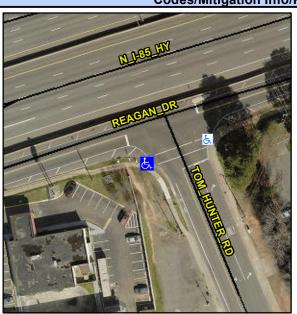
StopSign Street 1 Name Stop Condition-Street 1 TOM HUNTER RD N/A Street 2 Name Stop Condition-Street 2 N/A Possible Solutions: Compliance Description N/A Remove & Replace Entire Ramp. Yes No No N/A No Surveyor Notes: N/A **RP & RT RP < 5%** N/A N/A N/A N/A PROW/ADA: N/A Not Found, R304.5.1, R304.5.3, N/A R304.3.2 N/A N/A N/A N/A N/A
