Access Compliance Report

Public Rights-of-Way

(Curb Ramps)

Intersection ID: 29243	Main Street: WOODINGTON_LN	Cross Street: CARRINGTON_HILL_DR	Location: W
ADA ID: 701902A05CAC	Ramp Type: PerpDiag	Initial Pass/Fail: Fail	Overall Compliance: No
		Severity Score: 25

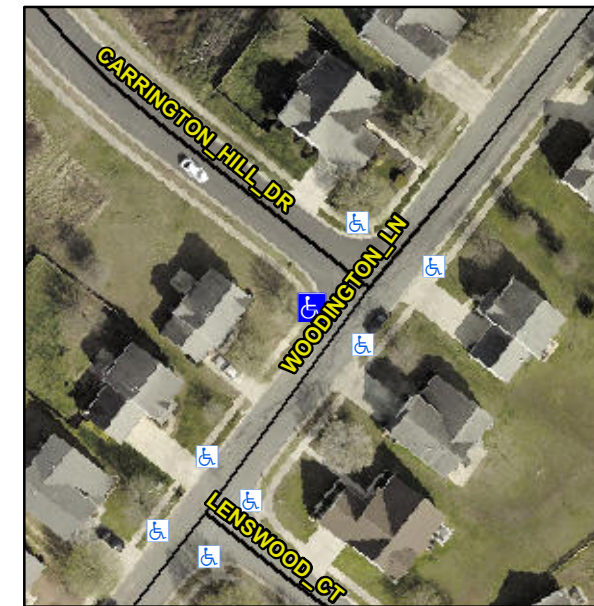
Not Found, R304.5.3

Compliance	Description	Data	Compliance	Description	Data
N/A	Ramp Length (in)	40.0	Yes	Ramp Slope (%)	5.0
Yes	Ramp Width (in)	48.0	No	Ramp XSlope (%)	11.8
N/A	Flare Type LT	N/A	N/A	Flare Type RT	N/A
N/A	Flare Slope LT (%)	N/A	N/A	Flare Slope RT (%)	N/A
N/A	Flare Traversable LT?	N/A	N/A	Flare Traversable RT?	N/A
N/A	Landing Length (in)	N/A	N/A	DWS Provided?	N/A
N/A	Landing Width (in)	N/A	N/A	DWS Contrast?	N/A
N/A	Landing Slope (%)	N/A	N/A	DWS Length (in)	N/A
N/A	Landing X Slope (%)	N/A	N/A	DWS Full Width?	N/A
N/A	Landing Curb? (Y/N)	N/A	N/A	DWS Offset (in)	N/A
N/A	Shared Landing?	N/A			
N/A	Gutter Ponding?	N/A	N/A	Gutter Slope (%)	N/A
N/A	Gutter Lip Ht (in)	N/A	N/A	Gutter X Slope (%)	N/A
N/A	Painted X Walk1?	No	N/A	Painted X Walk2?	No
	X Walk 1 Direction	To SE		X Walk 2 Direction	To NE
N/A	X Walk 1 Width (in)	N/A	N/A	X Walk 2 Width (in)	N/A
	X Walk 1 Slope (%)	3.6		X Walk 2 Slope (%)	4.4
	X Walk 1 X Slope (%)	5.5		X Walk 2 X Slope (%)	6.5

N/A	Ramp inside XWalk1?	N/A	N/A	Ramp inside XWalk2?	N/A
	Road Slope (%)	9.7	N/A	Clear Space?	N/A
	Road X Slope (%)	3.0	N/A	Clear Space to XWalk (in)	N/A
N/A	Any Obstructions?	N/A	N/A	Storm Grate/Utility Hazard?	N/A
	Obstruction Type			Storm Grate/Utility Type	
		N/A			N/A
			Yes	Surface Condition? (G/P)	Good

Remove & Replace Curb Ramp With Two New Directional Ramps or Equivalent.
