Access Compliance Report

Public Rights-of-Way

(Curb Ramps)

Intersection ID: 8113	Main Street: ORR_RD	Cross Street: GRIER_RD	Location: W
ADA ID: 70199F64E0DA	Ramp Type: Perp	Initial Pass/Fail: Fail	Overall Compliance: No
Severity Score: 13.75			
Codes/Mitigation Info/Possible Solution		Field Measurements/Component Compliance

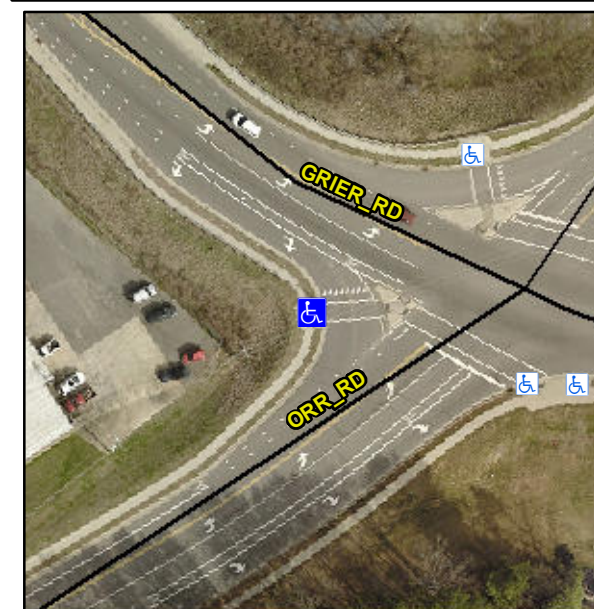
Not Found, R304.2.2, R304.5.3

Compliance	Description	Data	Compliance	Description	Data
N/A	Ramp Length (in)	48.0	No	Ramp Slope (%)	9.9
Yes	Ramp Width (in)	48.0	No	Ramp XSlope (%)	4.1
N/A	Flare Type LT	N/A	N/A	Flare Type RT	N/A
N/A	Flare Slope LT (%)	N/A	N/A	Flare Slope RT (%)	N/A
N/A	Flare Traversable LT?	N/A	N/A	Flare Traversable RT?	N/A
N/A	Landing Length (in)	N/A	N/A	DWS Provided?	N/A
N/A	Landing Width (in)	N/A	N/A	DWS Contrast?	N/A
N/A	Landing Slope (%)	N/A	N/A	DWS Length (in)	N/A
N/A	Landing X Slope (%)	N/A	N/A	DWS Full Width?	N/A
N/A	Landing Curb? (Y/N)	N/A	N/A	DWS Offset (in)	N/A
N/A	Shared Landing?	N/A			
N/A	Gutter Ponding?	N/A	N/A	Gutter Slope (%)	N/A
N/A	Gutter Lip Ht (in)	N/A	N/A	Gutter X Slope (%)	N/A
N/A	Painted X Walk1?	Yes	N/A	Painted X Walk2?	N/A
	X Walk 1 Direction	To SE		X Walk 2 Direction	N/A
N/A	X Walk 1 Width (in)	105.0	N/A	X Walk 2 Width (in)	N/A
	X Walk 1 Slope (%)	1.9		X Walk 2 Slope (%)	N/A
	X Walk 1 X Slope (%)	0.4		X Walk 2 X Slope (%)	N/A

N/A	Ramp inside XWalk1?	Yes	N/A	Ramp inside XWalk2?	N/A
	Road Slope (%)	N/A	N/A	Clear Space?	N/A
	Road X Slope (%)	N/A	N/A	Clear Space to XWalk (in)	N/A
N/A	Any Obstructions?	N/A	N/A	Storm Grate/Utility Hazard?	N/A
	Obstruction Type			Storm Grate/Utility Type	
		N/A			N/A
			Yes	Surface Condition? (G/P)	Good

Possible Solutions:

Remove & Replace Entire Ramp.
