Intersection ID: 11709	Main Street: W_7TH_ST	Cross Street: N_PINE_ST	Location:	N
ADA ID: 702EC93D11F6	Ramp Type: Perp	Initial Pass/Fail: Fail	Overall Compliance: No	Severity Score: 13.75

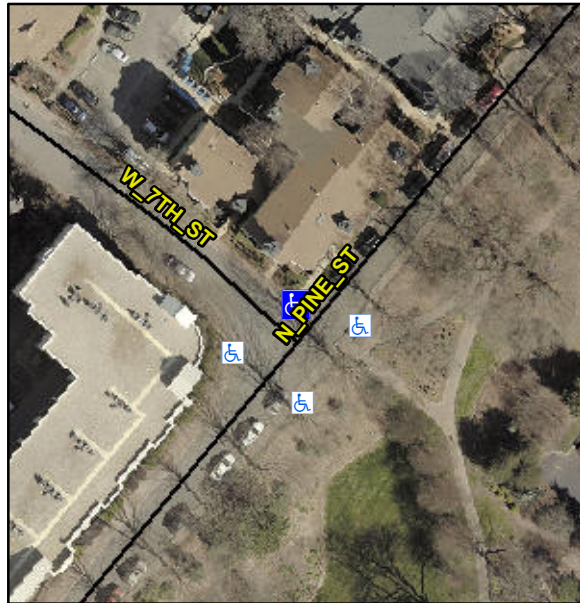
Not Found, R304.2.2, R304.5.3

Compliance	Description	Data	Compliance	Description	Data
N/A	Ramp Length (in)	63.0	No	Ramp Slope (%)	11.3
Yes	Ramp Width (in)	50.0	No	Ramp XSlope (%)	3.0
N/A	Flare Type LT	N/A	N/A	Flare Type RT	N/A
N/A	Flare Slope LT (%)	N/A	N/A	Flare Slope RT (%)	N/A
N/A	Flare Traversable LT?	N/A	N/A	Flare Traversable RT?	N/A
N/A	Landing Length (in)	N/A	N/A	DWS Provided?	N/A
N/A	Landing Width (in)	N/A	N/A	DWS Contrast?	N/A
N/A	Landing Slope (%)	N/A	N/A	DWS Length (in)	N/A
N/A	Landing X Slope (%)	N/A	N/A	DWS Full Width?	N/A
N/A	Landing Curb? (Y/N)	N/A	N/A	DWS Offset (in)	N/A
N/A	Shared Landing?	N/A			
N/A	Gutter Ponding?	N/A	N/A	Gutter Slope (%)	N/A
N/A	Gutter Lip Ht (in)	N/A	N/A	Gutter X Slope (%)	N/A
N/A	Painted X Walk1?	No	N/A	Painted X Walk2?	N/A
	X Walk 1 Direction	To SW		X Walk 2 Direction	N/A
N/A	X Walk 1 Width (in)	N/A	N/A	X Walk 2 Width (in)	N/A
	X Walk 1 Slope (%)	1.2		X Walk 2 Slope (%)	N/A
	X Walk 1 X Slope (%)	4.4		X Walk 2 X Slope (%)	N/A

N/A	Ramp inside XWalk1?	N/A	N/A	Ramp inside XWalk2?	N/A
	Road Slope (%)	N/A	N/A	Clear Space?	N/A
	Road X Slope (%)	N/A	N/A	Clear Space to XWalk (in)	N/A
N/A	Any Obstructions?	N/A	N/A	Storm Grate/Utility Hazard?	N/A
	Obstruction Type			Storm Grate/Utility Type	
		N/A			N/A
			Yes	Surface Condition? (G/P)	Good

Remove & Replace Entire Ramp.
