# Access Compliance Report Public Rights-of-Way (Curb Ramps)

| Intersection ID: 47585 | Main Street: EVANTON_LOCH_RD | Cross Street: SEAMILL_RD | Location: NE |
| ADA ID: 702F6B042047 | Ramp Type: PerpDiag | Initial Pass/Fail: Fail | Overall Compliance: No<br>Severity Score: 12.5 |

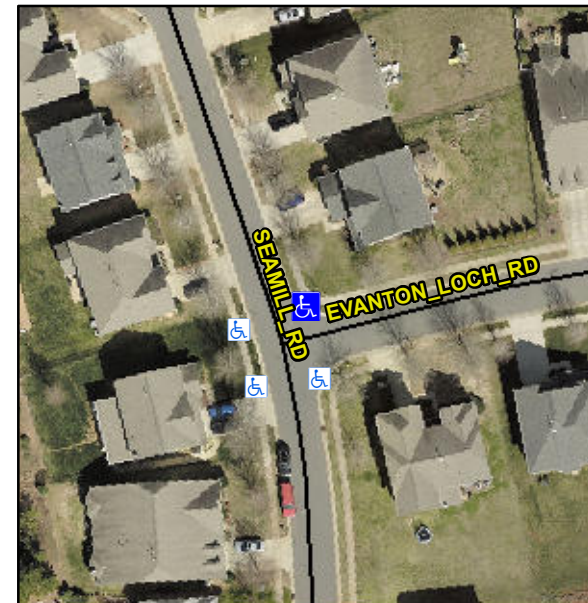
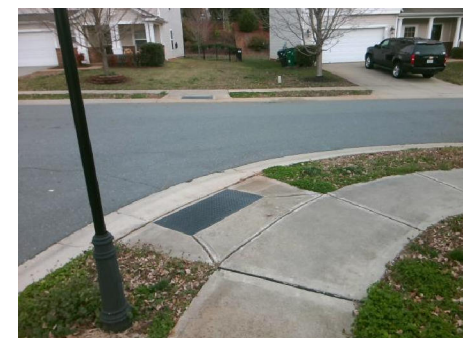
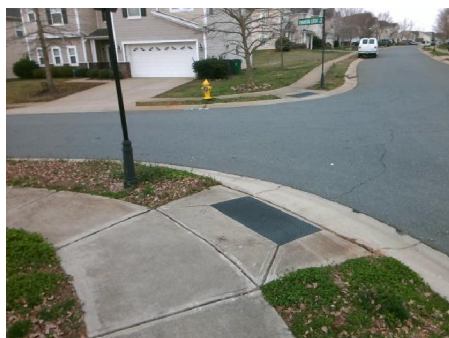
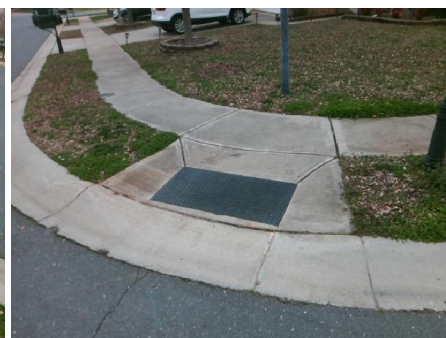
**R304.2.2**

| Compliance | Description | Data | Compliance | Description | Data |
|---|---|---|---|---|---|
| N/A | Ramp Length (in) | 48.0 | No | Ramp Slope (%) | 8.7 |

**Remove & Replace Curb Ramp With Two New Directional Ramps or Equivalent.**
