# Access Compliance Report

## Public Rights-of-Way

Intersection ID: 53894	Main Street: INVERNESS_BAY_RD	Cross Street: PERTH_MOOR_RD	Location: SE
ADA ID: 703B2B1DCF67	Ramp Type: Perp	Initial Pass/Fail: Fail	Overall Compliance: No
Severity Score: 12.5			
Codes/Mitigation Info/Possible Solution		Field Measurements/Component Compliance

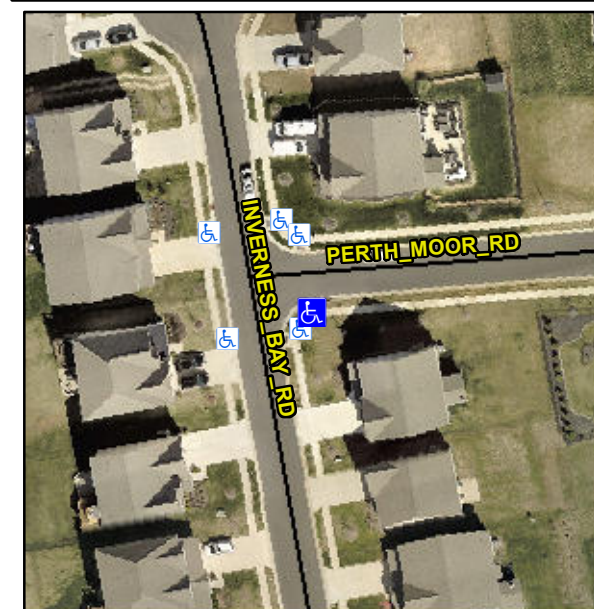
Compliance	Description	Data	Compliance	Description	Data
N/A	Ramp Length (in)	49.5	No	Ramp Slope (%)	8.4
Yes	Ramp Width (in)	48.0	Yes	Ramp XSlope (%)	0.2
N/A	Flare Type LT	N/A	N/A	Flare Type RT	N/A
N/A	Flare Slope LT (%)	N/A	N/A	Flare Slope RT (%)	N/A
N/A	Flare Traversable LT?	N/A	N/A	Flare Traversable RT?	N/A
N/A	Landing Length (in)	N/A	N/A	DWS Provided?	N/A
N/A	Landing Width (in)	N/A	N/A	DWS Contrast?	N/A
N/A	Landing Slope (%)	N/A	N/A	DWS Length (in)	N/A
N/A	Landing X Slope (%)	N/A	N/A	DWS Full Width?	N/A
N/A	Landing Curb? (Y/N)	N/A	N/A	DWS Offset (in)	N/A
N/A	Shared Landing?	N/A			
N/A	Gutter Ponding?	N/A	N/A	Gutter Slope (%)	N/A
N/A	Gutter Lip Ht (in)	0.5	N/A	Gutter X Slope (%)	N/A
N/A	Painted X Walk1?	No	N/A	Painted X Walk2?	N/A
	X Walk 1 Direction	To N		X Walk 2 Direction	N/A
N/A	X Walk 1 Width (in)	N/A	N/A	X Walk 2 Width (in)	N/A
	X Walk 1 Slope (%)	4.6		X Walk 2 Slope (%)	N/A
	X Walk 1 X Slope (%)	0.7		X Walk 2 X Slope (%)	N/A

Possible Solutions:

**Remove & Replace Entire Ramp.**

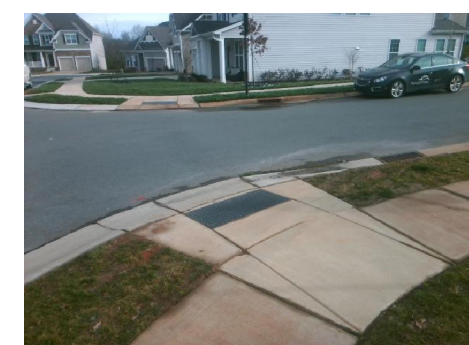
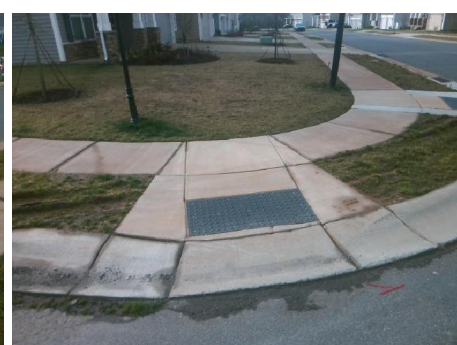
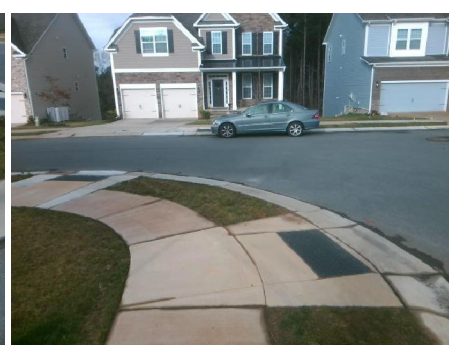
N/A	Ramp inside XWalk1?	N/A	N/A	Ramp inside XWalk2?	N/A
	Road Slope (%)	N/A	N/A	Clear Space?	N/A
	Road X Slope (%)	N/A	N/A	Clear Space to XWalk (in)	N/A
N/A	Any Obstructions?	N/A	N/A	Storm Grate/Utility Hazard?	N/A
	Obstruction Type			Storm Grate/Utility Type	
		N/A			N/A
			Yes	Surface Condition? (G/P)	Good
