Access Compliance Report

Public Rights-of-Way

(Curb Ramps)

Intersection ID: 9739	Main Street: FAIRFIELD_ST	Cross Street: PATTON_AV	Location: NW
ADA ID: 705932A6F8CA	Ramp Type: Directional1	Initial Pass/Fail: Pass	Overall Compliance: No
		Severity Score: 15

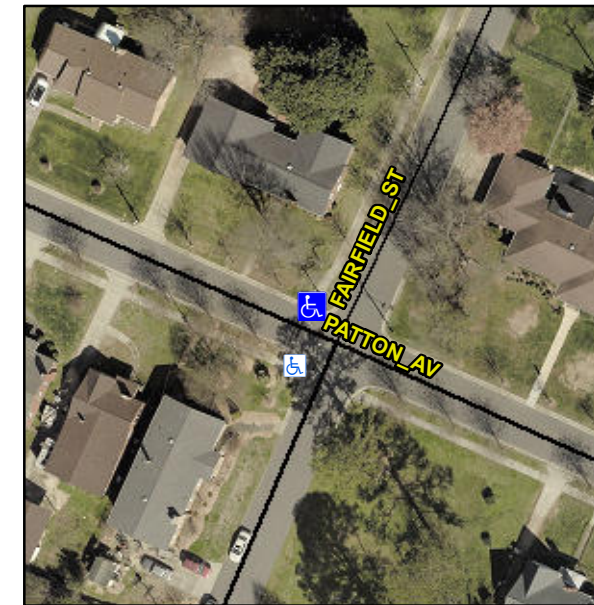
**Not Found, R305.1.4, R305.2,
R302.7.2, R304.5.4**

Compliance	Description	Data	Compliance	Description	Data
N/A	Ramp Length (in)	121.0	N/A	Grade Break?	N/A
Yes	Ramp Width (in)	59.0	N/A	Grade Break Slope (%)	0.0
Yes	Ramp Slope (%)	3.4	N/A	Grade Break XSlope (%)	0.0
Yes	Ramp XSlope (%)	1.7			
Yes	Flare Type LT	N/A	Yes	Flare Type RT	N/A
N/A	Flare Slope LT (%)	N/A	N/A	Flare Slope RT (%)	N/A
N/A	Flare Traversable LT?	No	N/A	Flare Traversable RT?	No
Yes	Landing Length (in)	61.5	Yes	DWS Provided?	Yes
Yes	Landing Width (in)	60.0	Yes	DWS Contrast?	Yes
Yes	Landing Slope (%)	1.4	Yes	DWS Length (in)	24.0
Yes	Landing X Slope (%)	2.3	No	DWS Full Width?	No
N/A	Landing Curb? (Y/N)	No	No	DWS Offset LT (in)	4.3
N/A	Shared Landing?	No	Yes	DWS Offset RT (in)	4.3
Yes	Gutter Ponding?	No	No	Gutter Slope (%)	5.3
No	Gutter Lip Ht (in)	0.3	Yes	Gutter X Slope (%)	2.6
N/A	Painted X Walk1?	No		Road Slope (%)	0.3
	X Walk 1 Direction	To SW		Road X Slope (%)	3.3
	X Walk 1 Width (in)	N/A		Clear Space?	Yes

X Walk 1 Slope (%)	0.3	N/A	Clear Space to XWalk (in)	N/A
	X Walk 1 X Slope (%)	3.3	Yes	Storm Grate/Utility Hazard?	No
N/A	Ramp inside XWalk1?	N/A		Storm Grate/Utility Type	
Yes	Any Obstructions?	No			N/A
	Obstruction Type		Yes	Surface Condition? (G/P)	Good
			N/A	Curb Slope (%)	22.3

**Remove & Replace Entire Ramp.
Remove & Replace Gutter.**
