Access Compliance Report

Public Rights-of-Way

(Curb Ramps)

Intersection ID: 31711	Main Street: WEEPING FIG LN	Cross Street: BLUE ASH LN	Location: E
ADA ID: 706A4C2F2A54	Ramp Type: PerpDiag	Initial Pass/Fail: Fail	Overall Compliance: No
Severity Score: 33.75			
Codes/Mitigation Info/Possible Solution		Field Measurements/Component Compliance

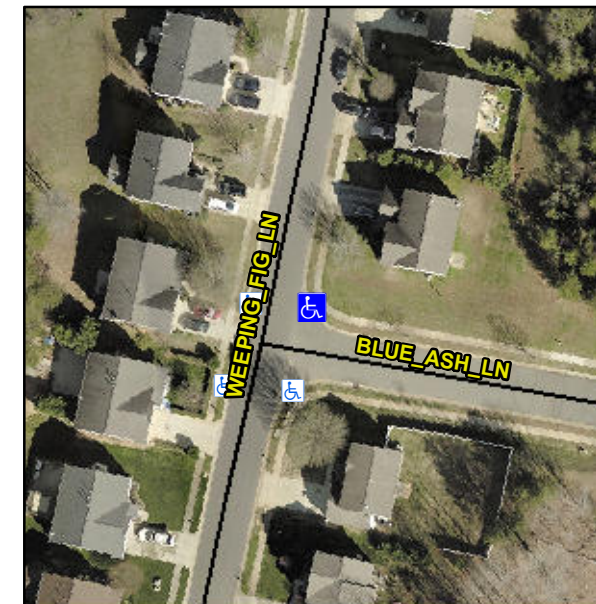
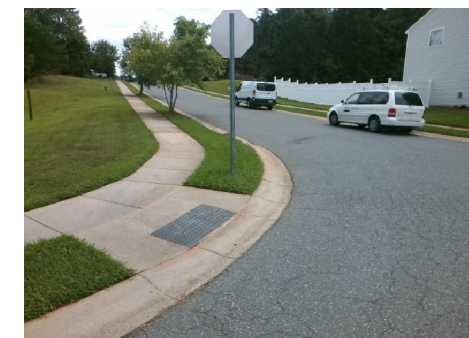
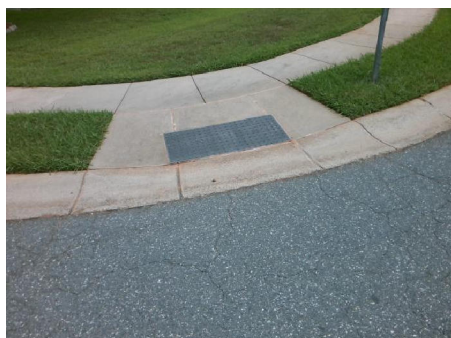
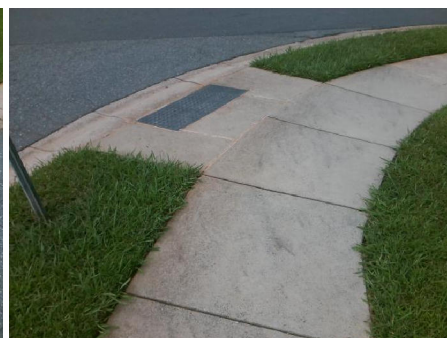
Not Found, R304.5.1, R304.2.2, R304.5.3

Compliance	Description	Data	Compliance	Description	Data
N/A	Ramp Length (in)	47.0	No	Ramp Slope (%)	9.9
No	Ramp Width (in)	39.0	No	Ramp XSlope (%)	6.0
N/A	Flare Type LT	N/A	N/A	Flare Type RT	N/A
N/A	Flare Slope LT (%)	N/A	N/A	Flare Slope RT (%)	N/A
N/A	Flare Traversable LT?	N/A	N/A	Flare Traversable RT?	N/A
N/A	Landing Length (in)	N/A	N/A	DWS Provided?	N/A
N/A	Landing Width (in)	N/A	N/A	DWS Contrast?	N/A
N/A	Landing Slope (%)	N/A	N/A	DWS Length (in)	N/A
N/A	Landing X Slope (%)	N/A	N/A	DWS Full Width?	N/A
N/A	Landing Curb? (Y/N)	N/A	N/A	DWS Offset (in)	N/A
N/A	Shared Landing?	N/A			
N/A	Gutter Ponding?	N/A	N/A	Gutter Slope (%)	N/A
N/A	Gutter Lip Ht (in)	0.5	N/A	Gutter X Slope (%)	N/A
N/A	Painted X Walk1?	No	N/A	Painted X Walk2?	No
	X Walk 1 Direction	To NW		X Walk 2 Direction	To SW
N/A	X Walk 1 Width (in)	N/A	N/A	X Walk 2 Width (in)	N/A
	X Walk 1 Slope (%)	2.2		X Walk 2 Slope (%)	6.3
	X Walk 1 X Slope (%)	5.1		X Walk 2 X Slope (%)	3.0

N/A	Ramp inside XWalk1?	N/A	N/A	Ramp inside XWalk2?	N/A
	Road Slope (%)	4.3	N/A	Clear Space?	N/A
	Road X Slope (%)	2.4	N/A	Clear Space to XWalk (in)	N/A
N/A	Any Obstructions?	N/A	N/A	Storm Grate/Utility Hazard?	N/A
	Obstruction Type			Storm Grate/Utility Type	
		N/A			N/A
			Yes	Surface Condition? (G/P)	Good

Remove & Replace Curb Ramp With Two New Directional Ramps or Equivalent.
