Access Compliance Report Public Rights-of-Way (Curb Ramps)

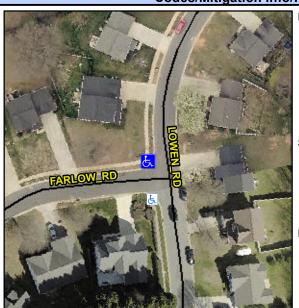
Intersection ID: 4842 Main Street: FARLOW_RD Cross Street: LOWEN_RD Location: NW **Overall Compliance: No** ADA ID: 707EC5552C5C Ramp Type: Perp Initial Pass/Fail: Fail **Severity Score:** 55

Field Measurements/Component Compilance							
Comp	iance Description	Data	Compl	iance Description	Data		
N/A	Ramp Length (in)	49.0	No	Ramp Slope (%)	8.9		
No	Ramp Width (in)	35.0	No	Ramp XSlope (%)	8.8		
N/A	Flare Type LT	N/A	N/A	Flare Type RT	N/A		
N/A	Flare Slope LT (%)	N/A	N/A	Flare Slope RT (%)	N/A		
N/A	Flare Traversable LT?	N/A	N/A	Flare Traversable RT?	N/A		
N/A	Landing Length (in)	N/A	N/A	DWS Provided?	N/A		
N/A	Landing Width (in)	N/A	N/A	DWS Contrast?	N/A		
N/A	Landing Slope (%)	N/A	N/A	DWS Length (in)	N/A		
N/A	Landing X Slope (%)	N/A	N/A	DWS Full Width?	N/A		
N/A	Landing Curb? (Y/N)	N/A	N/A	DWS Offset (in)	N/A		
N/A	Shared Landing?	N/A					
N/A	Gutter Ponding?	N/A	N/A	Gutter Slope (%)	N/A		
N/A	Gutter Lip Ht (in)	N/A	N/A	Gutter X Slope (%)	N/A		
N/A	Painted X Walk1?	No	N/A	Painted X Walk2?	N/A		
	X Walk 1 Direction	To S		X Walk 2 Direction	N/A		
N/A	X Walk 1 Width (in)	N/A	N/A	X Walk 2 Width (in)	N/A

X Walk 1 Slope (%)	0.9		X Walk 2 Slope (%)	N/A		
	X Walk 1 X Slope (%)	7.5		X Walk 2 X Slope (%)	N/A		
N/A	Ramp inside XWalk1?	N/A	N/A	Ramp inside XWalk2?	N/A		
	Road Slope (%)	N/A	N/A	Clear Space?	N/A		
	Road X Slope (%)	N/A	N/A	Clear Space to XWalk (in)	N/A		
N/A	Any Obstructions?	N/A	N/A	Storm Grate/Utility Hazard?	N/A		
	Obstruction Type			Storm Grate/Utility Type			
		N/A			N/A		
			Yes	Surface Condition? (G/P)	Good		
200

Possible Solutions:	Co
Remove & Replace Entire Ramp.	N/A
·	No
	N/A
	N/A
	N/A
	N/A
Surveyor Notes:	N/A
N/A	N/A
	N/A
	N/A
	N/A
PROW/ADA:	N/A
Not Found, R304.5.1, R304.2.2,	N/A
R304.5.3	N/A
	N/A
	N/A
