Intersection ID: 15316	Main Street: CARLING_AV	Cross Street: CHARLOTTE_DR	Location:	N
ADA ID: 708D692E5A26	Ramp Type: Perp	Initial Pass/Fail: Fail	Overall Compliance: No	Severity Score: 13.75

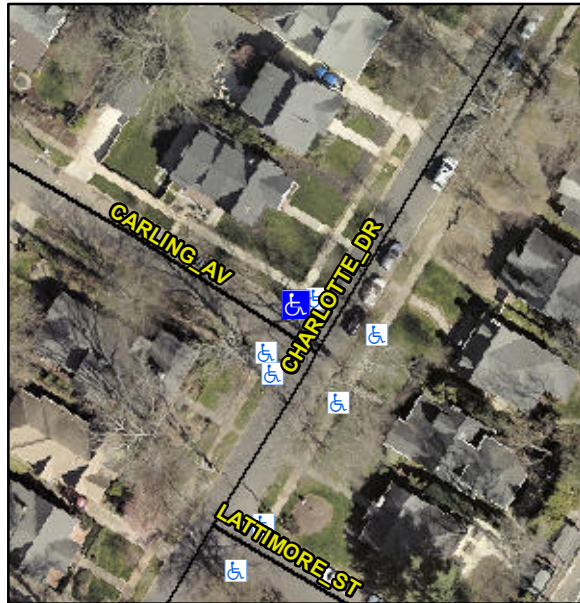
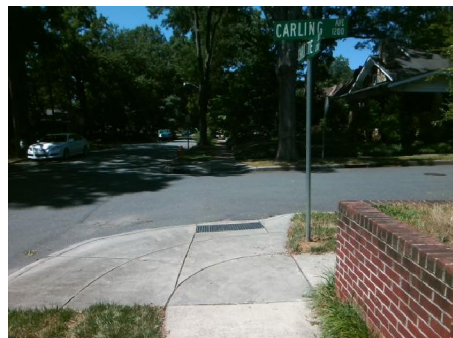
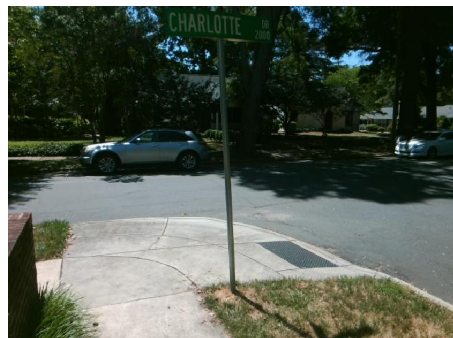
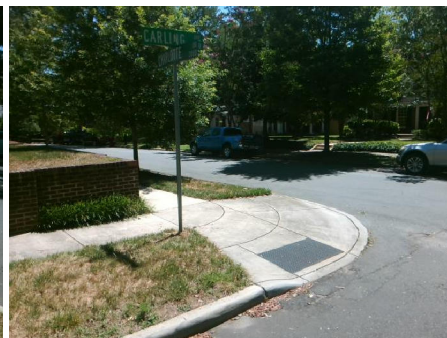
Not Found, R304.2.2, R304.5.3

Possible Solutions:			Compliance	Description	Data	Compliance	Description	Data
Remove & Replace Entire Ramp.	N/A	Ramp Length (in)	85.0	No	Ramp Slope (%)	9.6		
	Yes	Ramp Width (in)	48.0	No	Ramp XSlope (%)	4.6		
	N/A	Flare Type LT	N/A	N/A	Flare Type RT	N/A		
	N/A	Flare Slope LT (%)	N/A	N/A	Flare Slope RT (%)	N/A		
	N/A	Flare Traversable LT?	N/A	N/A	Flare Traversable RT?	N/A		
	N/A	Landing Length (in)	N/A	N/A	DWS Provided?	N/A		
	N/A	Landing Width (in)	N/A	N/A	DWS Contrast?	N/A		
	N/A	Landing Slope (%)	N/A	N/A	DWS Length (in)	N/A		
	N/A	Landing X Slope (%)	N/A	N/A	DWS Full Width?	N/A		
	N/A	Landing Curb? (Y/N)	N/A	N/A	DWS Offset (in)	N/A		
Surveyor Notes: N/A	N/A	Shared Landing?	N/A					
	N/A	Gutter Ponding?	N/A	N/A	Gutter Slope (%)	N/A		
	N/A	Gutter Lip Ht (in)	N/A	N/A	Gutter X Slope (%)	N/A		
	N/A	Painted X Walk1?	No	N/A	Painted X Walk2?	N/A		
		X Walk 1 Direction	To SW		X Walk 2 Direction	N/A		
	N/A	X Walk 1 Width (in)	N/A	N/A	X Walk 2 Width (in)	N/A

X Walk 1 Slope (%)	4.8		X Walk 2 Slope (%)	N/A		
		X Walk 1 X Slope (%)	4.5		X Walk 2 X Slope (%)	N/A		
	N/A	Ramp inside XWalk1?	N/A	N/A	Ramp inside XWalk2?	N/A		
		Road Slope (%)	N/A	N/A	Clear Space?	N/A		
PROW/ADA: Not Found, R304.2.2, R304.5.3		Road X Slope (%)	N/A	N/A	Clear Space to XWalk (in)	N/A		
	N/A	Any Obstructions?	N/A	N/A	Storm Grate/Utility Hazard?	N/A		
		Obstruction Type			Storm Grate/Utility Type			
			N/A			N/A		
				Yes	Surface Condition? (G/P)	Good		
Total Cost:	\$	1850.00

Remove & Replace Entire Ramp.
