# Access Compliance Report

## Public Rights-of-Way

### (Curb Ramps)

Intersection ID: 19746	Main Street: PINEBURR_RD	Cross Street: THERMAL_RD	Location: S
ADA ID: 7097A2CC38AE	Ramp Type: PerpDiag	Initial Pass/Fail: Fail	Overall Compliance: No
Severity Score: 33.75			
Codes/Mitigation Info/Possible Solution		Field Measurements/Component Compliance

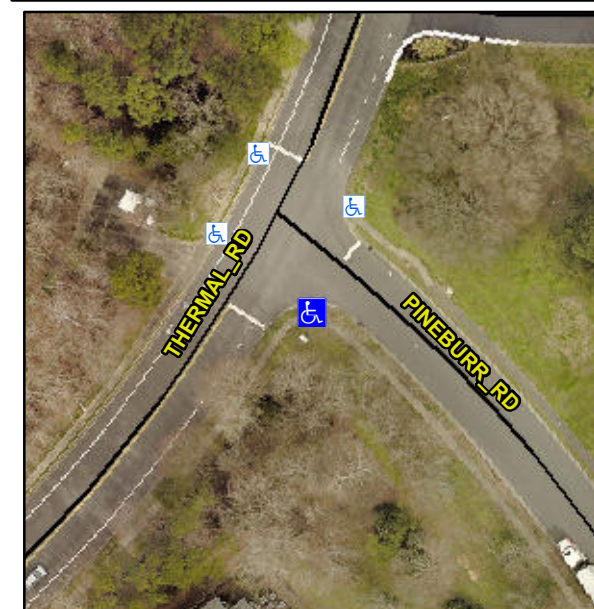
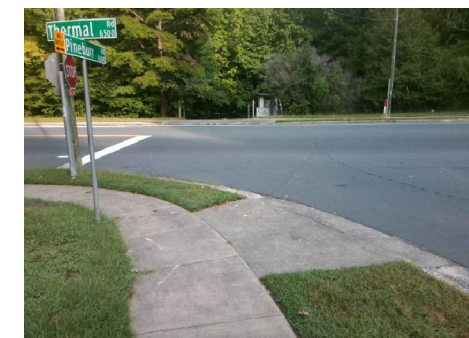
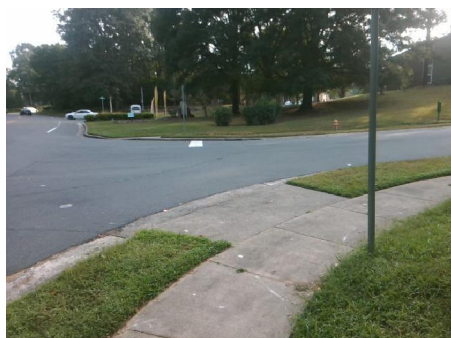
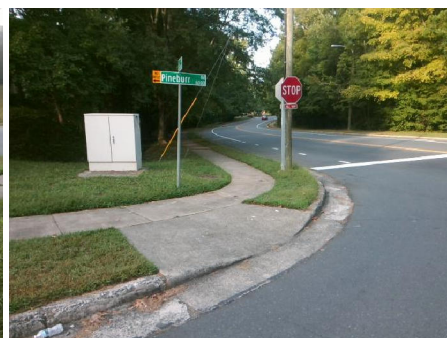
Compliance	Description	Data	Compliance	Description	Data
N/A	Ramp Length (in)	71.0	Yes	Ramp Slope (%)	8.2
No	Ramp Width (in)	46.0	No	Ramp XSlope (%)	7.9
N/A	Flare Type LT	N/A	N/A	Flare Type RT	N/A
N/A	Flare Slope LT (%)	N/A	N/A	Flare Slope RT (%)	N/A
N/A	Flare Traversable LT?	N/A	N/A	Flare Traversable RT?	N/A
N/A	Landing Length (in)	N/A	N/A	DWS Provided?	N/A
N/A	Landing Width (in)	N/A	N/A	DWS Contrast?	N/A
N/A	Landing Slope (%)	N/A	N/A	DWS Length (in)	N/A
N/A	Landing X Slope (%)	N/A	N/A	DWS Full Width?	N/A
N/A	Landing Curb? (Y/N)	N/A	N/A	DWS Offset (in)	N/A
N/A	Shared Landing?	N/A			
N/A	Gutter Ponding?	N/A	N/A	Gutter Slope (%)	N/A
N/A	Gutter Lip Ht (in)	N/A	N/A	Gutter X Slope (%)	N/A
N/A	Painted X Walk1?	No	N/A	Painted X Walk2?	No
	X Walk 1 Direction	To NE		X Walk 2 Direction	To NW
N/A	X Walk 1 Width (in)	N/A	N/A	X Walk 2 Width (in)	N/A
	X Walk 1 Slope (%)	5.8		X Walk 2 Slope (%)	2.1
	X Walk 1 X Slope (%)	2.5		X Walk 2 X Slope (%)	2.8

N/A	Ramp inside XWalk1?	N/A	N/A	Ramp inside XWalk2?	N/A
	Road Slope (%)	5.5	N/A	Clear Space?	N/A
	Road X Slope (%)	3.1	N/A	Clear Space to XWalk (in)	N/A
N/A	Any Obstructions?	N/A	N/A	Storm Grate/Utility Hazard?	N/A
	Obstruction Type			Storm Grate/Utility Type	
		N/A			N/A
			Yes	Surface Condition? (G/P)	Good

**Remove & Replace Curb Ramp With Two New Directional Ramps or Equivalent.**

**R304.5.1, R304.5.3**
