Access Compliance Report

Public Rights-of-Way

(Curb Ramps)

Intersection ID: 15459	Main Street: CONISTON_PL	Cross Street: S_KINGS_DR	Location: NE
ADA ID: 70AFE264B5FA	Ramp Type: Directional1	Initial Pass/Fail: Fail	Overall Compliance: No
		Severity Score: 1.25

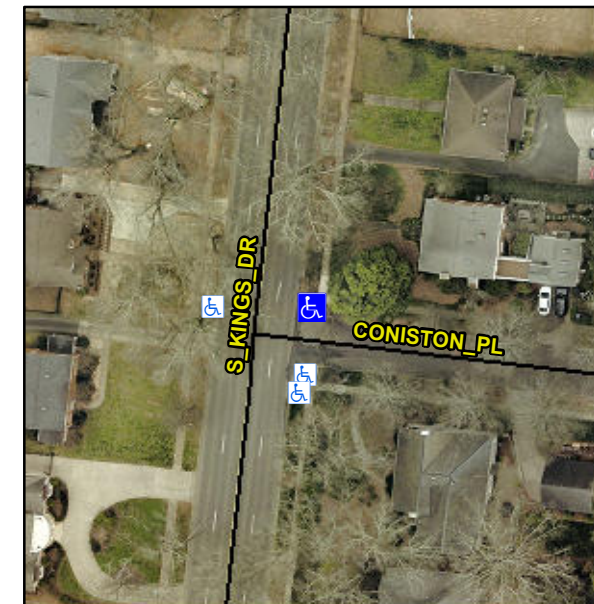
R304.5.3

Compliance	Description	Data	Compliance	Description	Data
N/A	Ramp Length (in)	84.0	N/A	Grade Break?	N/A
Yes	Ramp Width (in)	59.0	N/A	Grade Break Slope (%)	0.0
Yes	Ramp Slope (%)	7.6	N/A	Grade Break XSlope (%)	0.0
No	Ramp XSlope (%)	3.1			
N/A	Flare Type LT	N/A	N/A	Flare Type RT	N/A
N/A	Flare Slope LT (%)	N/A	N/A	Flare Slope RT (%)	0.0
N/A	Flare Traversable LT?	N/A	N/A	Flare Traversable RT?	N/A
N/A	Landing Length (in)	0.0	N/A	DWS Provided?	N/A
N/A	Landing Width (in)	0.0	N/A	DWS Contrast?	N/A
N/A	Landing Slope (%)	0.0	N/A	DWS Length (in)	N/A
N/A	Landing X Slope (%)	0.0	N/A	DWS Full Width?	N/A
N/A	Landing Curb? (Y/N)	N/A	N/A	DWS Offset LT (in)	N/A
N/A	Shared Landing?	N/A	N/A	DWS Offset RT (in)	N/A
N/A	Gutter Ponding?	0.0	N/A	Gutter Slope (%)	N/A
N/A	Gutter Lip Ht (in)	0.0	N/A	Gutter X Slope (%)	N/A
N/A	Painted X Walk1?	No		Road Slope (%)	4.6
	X Walk 1 Direction	To SE		Road X Slope (%)	2.0
	X Walk 1 Width (in)	N/A		Clear Space?	N/A

X Walk 1 Slope (%)	4.6	N/A	Clear Space to XWalk (in)	N/A
	X Walk 1 X Slope (%)	2.0	N/A	Storm Grate/Utility Hazard?	N/A
N/A	Ramp inside XWalk1?	N/A		Storm Grate/Utility Type	
N/A	Any Obstructions?	N/A			N/A
	Obstruction Type		Yes	Surface Condition? (G/P)	Good
			N/A	Curb Slope (%)	1.2

Remove & Replace Entire Ramp.
