# Access Compliance Report

## Public Rights-of-Way

### (Curb Ramps)

Intersection ID: 31445	Main Street: RIDING_HILL_AV	Cross Street: UNDERWOOD_AV	Location: E
ADA ID: 70BFEF79E639	Ramp Type: PerpDiag	Initial Pass/Fail: Fail	Overall Compliance: No
Severity Score: 21.25			
Codes/Mitigation Info/Possible Solution		Field Measurements/Component Compliance

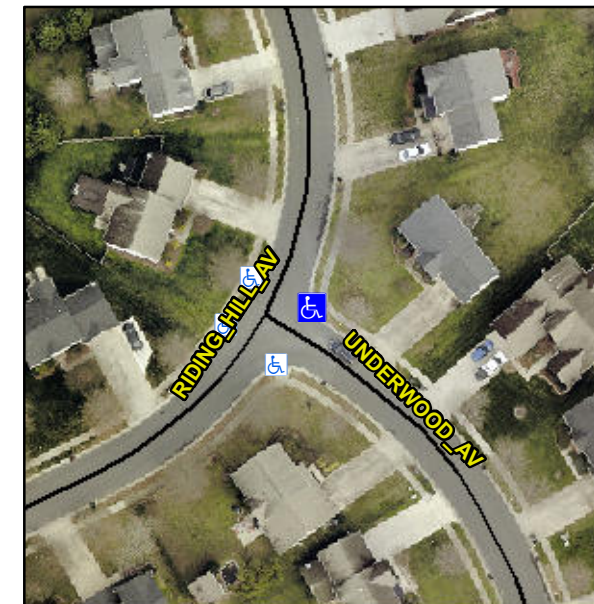
**Not Found, R304.5.1, R304.2.2**

Compliance	Description	Data	Compliance	Description	Data
N/A	Ramp Length (in)	48.0	No	Ramp Slope (%)	8.5
No	Ramp Width (in)	45.0	Yes	Ramp XSlope (%)	0.6
N/A	Flare Type LT	N/A	N/A	Flare Type RT	N/A
N/A	Flare Slope LT (%)	N/A	N/A	Flare Slope RT (%)	N/A
N/A	Flare Traversable LT?	N/A	N/A	Flare Traversable RT?	N/A
N/A	Landing Length (in)	N/A	N/A	DWS Provided?	N/A
N/A	Landing Width (in)	N/A	N/A	DWS Contrast?	N/A
N/A	Landing Slope (%)	N/A	N/A	DWS Length (in)	N/A
N/A	Landing X Slope (%)	N/A	N/A	DWS Full Width?	N/A
N/A	Landing Curb? (Y/N)	N/A	N/A	DWS Offset (in)	N/A
N/A	Shared Landing?	N/A			
N/A	Gutter Ponding?	N/A	N/A	Gutter Slope (%)	N/A
N/A	Gutter Lip Ht (in)	N/A	N/A	Gutter X Slope (%)	N/A
N/A	Painted X Walk1?	No	N/A	Painted X Walk2?	No
	X Walk 1 Direction	To NW		X Walk 2 Direction	To SW
N/A	X Walk 1 Width (in)	N/A	N/A	X Walk 2 Width (in)	N/A
	X Walk 1 Slope (%)	1.7		X Walk 2 Slope (%)	1.4
	X Walk 1 X Slope (%)	0.9		X Walk 2 X Slope (%)	1.3

N/A	Ramp inside XWalk1?	N/A	N/A	Ramp inside XWalk2?	N/A
	Road Slope (%)	3.8	N/A	Clear Space?	N/A
	Road X Slope (%)	0.0	N/A	Clear Space to XWalk (in)	N/A
N/A	Any Obstructions?	N/A	N/A	Storm Grate/Utility Hazard?	N/A
	Obstruction Type			Storm Grate/Utility Type	
		N/A			N/A
		Yes		Surface Condition? (G/P)	Good

**Remove & Replace Curb Ramp With Two New Directional Ramps or Equivalent.**
