# Access Compliance Report

## Public Rights-of-Way

| Intersection ID: 50616 | Main Street: PADDLE_OAK_RD | Cross Street: FAWN_LILY | Location: SE |
| ADA ID: 70D6D9B2C8AC | Ramp Type: Perp | Initial Pass/Fail: Fail | Overall Compliance: No |

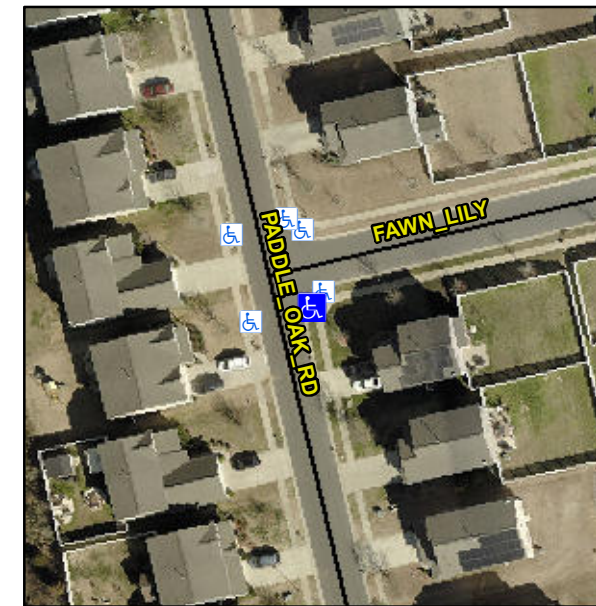
| Severity Score: 12.5 | | | |

**R304.5.3**

| Compliance | Description | Data | Compliance | Description | Data |
|---|---|---|---|---|---|
| Yes | Ramp Width (in) | 48.0 | No | Ramp XSlope (%) | 6.6 |

**Remove & Replace Entire Ramp.**

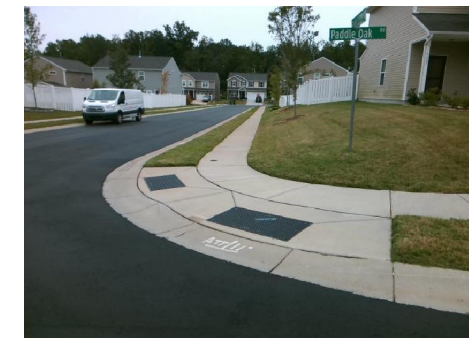
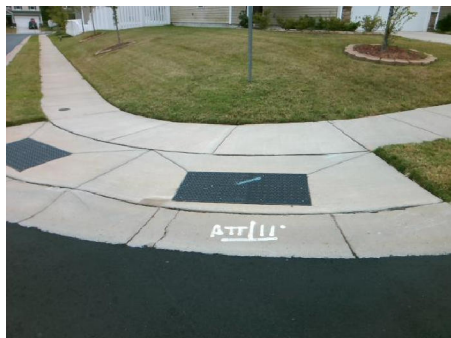
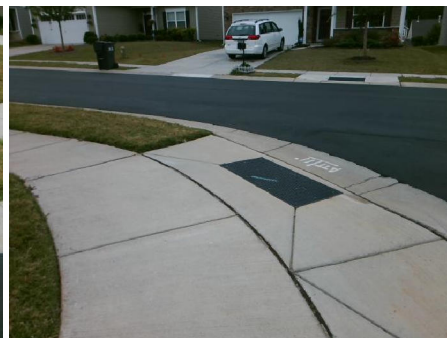
| Compliance | Description | Data | Compliance | Description | Data |
|---|---|---|---|---|---|
| | | | Yes | Surface Condition? (G/P) | Good |
