Access Compliance Report

Public Rights-of-Way

(Curb Ramps)

Intersection ID: 44112	Main Street: RIDING_HILL_AV	Cross Street: MERSEYSIDE_CT	Location: NE
ADA ID: 70DDEA9B1D98	Ramp Type: BlendTrans1	Initial Pass/Fail: Fail	Overall Compliance: No
Severity Score: 8.75			
Codes/Mitigation Info/Possible Solution		Field Measurements/Component Compliance

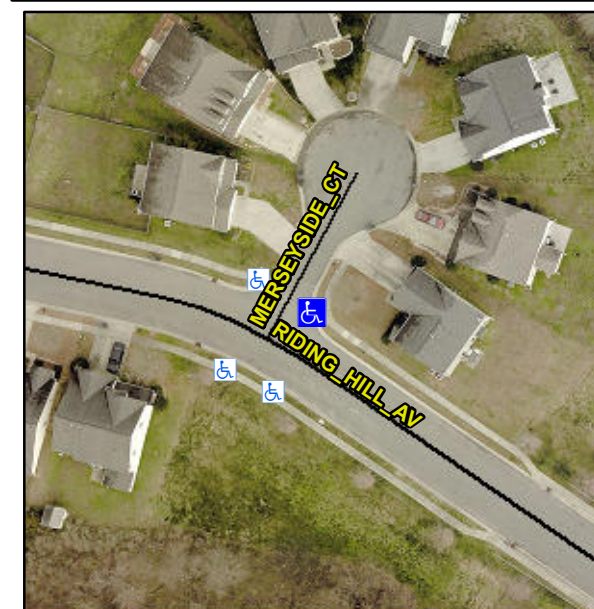
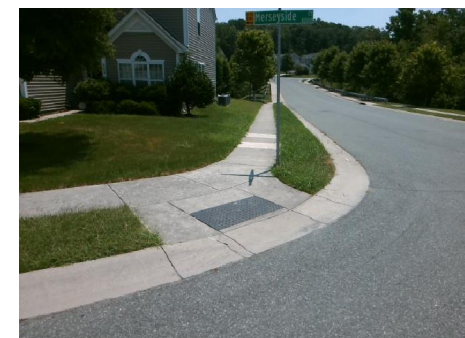
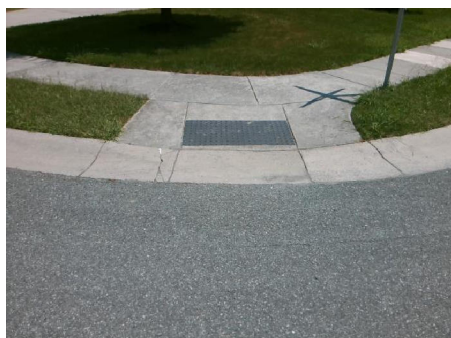
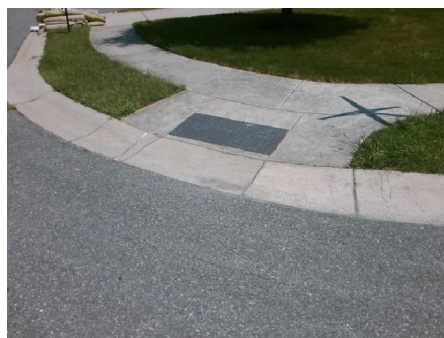
Not Found, R304.5.1

Compliance	Description	Data	Compliance	Description	Data
N/A	Ramp Length (in)	47.0	Yes	BlendTrans Slope (%)	4.4
No	Ramp Width (in)	47.5	Yes	BlendTrans XSlope (%)	1.2
N/A	Flare Type LT	N/A	N/A	Flare Type RT	N/A
N/A	Flare Slope LT (%)	N/A	N/A	Flare Slope RT (%)	N/A
N/A	Flare Traversable LT?	N/A	N/A	Flare Traversable RT?	N/A
N/A	Landing Length (in)	N/A	N/A	DWS Provided?	N/A
N/A	Landing Width (in)	N/A	N/A	DWS Contrast?	N/A
N/A	Landing Slope (%)	N/A	N/A	DWS Length (in)	N/A
N/A	Landing X Slope (%)	N/A	N/A	DWS Full Width?	N/A
N/A	Landing Curb? (Y/N)	N/A	N/A	DWS Offset (in)	N/A
N/A	Shared Landing?	N/A			
N/A	Gutter Ponding?	N/A	N/A	Gutter Slope (%)	N/A
N/A	Gutter Lip Ht (in)	N/A	N/A	Gutter X Slope (%)	N/A
N/A	Painted X Walk1?	No	N/A	Painted X Walk2?	No
	X Walk 1 Direction	To NW		X Walk 2 Direction	To SW
	X Walk 1 Width (in)	N/A		X Walk 2 Width (in)	N/A
	X Walk 1 Slope (%)	4.0		X Walk 2 Slope (%)	3.3
	X Walk 1 X Slope (%)	0.2		X Walk 2 X Slope (%)	3.8

N/A	Ramp inside XWalk1?	N/A	N/A	Ramp inside XWalk2?	N/A
	Road Slope (%)	1.3		Clear Space?	N/A
	Road X Slope (%)	4.4	N/A	Clear Space to XWalk (in)	N/A
N/A	Any Obstructions?	N/A	N/A	Storm Grate/Utility Hazard?	N/A
	Obstruction Type			Storm Grate/Utility Type	
		N/A			N/A
			Yes	Surface Condition? (G/P)	Good
			No	Curb Slope (%)	8.6

Remove & Replace Curb Ramp With Two New Directional Ramps or Equivalent.
