Access Compliance Report Public Rights-of-Way (Curb Ramps)

Intersection ID: 14267 Main Street: CLANTON_RD **Cross Street: FARMER_ST** Location: SW **ADA ID: 70E0107BFEBF** Ramp Type: Directional1 Initial Pass/Fail: Fail **Overall Compliance: No Severity Score:** 12.5

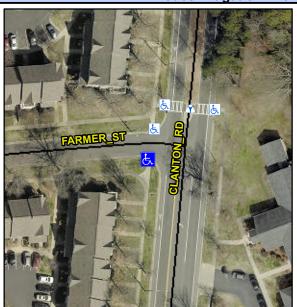
/Possible Solution			Field Measurements/Component Compliance				
Possible Solutions:			Compliance Description		Data	Compliance Description	
Remove & Replace En	itire Ran	np.	N/A	Ramp Length (in)	70.0	N/A	Grade Break?
·		•	Yes	Ramp Width (in)	48.0	N/A	Grade Break Slope (%)
			No	Ramp Slope (%)	9.6	N/A	Grade Break XSlope (%)
			Yes	Ramp XSlope (%)	0.6		
			N/A	Flare Type LT	N/A	N/A	Flare Type RT
			N/A	Flare Slope LT (%)	N/A	N/A	Flare Slope RT (%)
Surveyor Notes:			N/A	Flare Traversable LT?	N/A	N/A	Flare Traversable RT?
N/A			N/A	Landing Length (in)	0.0	N/A	DWS Provided?
			N/A	Landing Width (in)	0.0	N/A	DWS Contrast?
			N/A	Landing Slope (%)	0.0	N/A	DWS Length (in)
			N/A	Landing X Slope (%)	0.0	N/A	DWS Full Width?
PROW/ADA:			N/A	Landing Curb? (Y/N)	N/A	N/A	DWS Offset LT (in)
R304.2.2			N/A	Shared Landing?	N/A	N/A	DWS Offset RT (in)
			N/A	Gutter Ponding?	0.0	N/A	Gutter Slope (%)
			N/A	Gutter Lip Ht (in)	0.0	N/A	Gutter X Slope (%)
