# Access Compliance Report

## Public Rights-of-Way

| Intersection ID: 8312 | Main Street: HOVIS_RD | Cross Street: PONDEROSA_ST | Location: W |
| ADA ID: 70E1E80C3E3B | Ramp Type: Directional1 | Initial Pass/Fail: Fail | Overall Compliance: No |

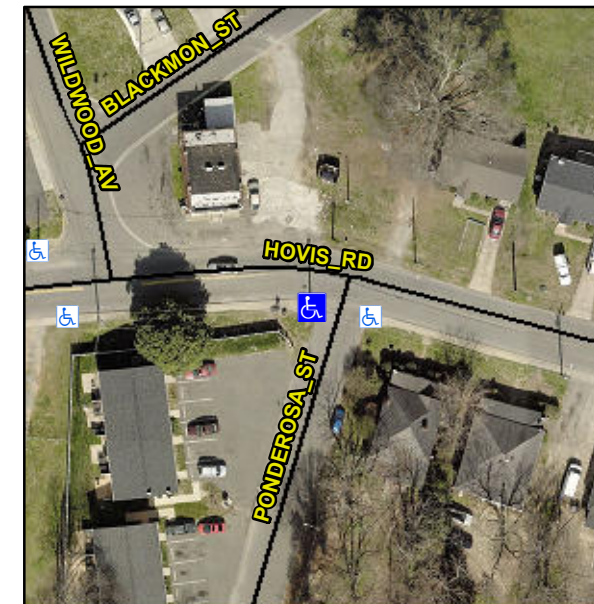
| | | | Severity Score: 13.75 |

**R304.2.2, R304.5.3**

| Compliance | Description | Data | Compliance | Description | Data |
|---|---|---|---|---|---|
| No | Ramp Slope (%) | 8.4 | N/A | Grade Break XSlope (%) | 0.0 |
| No | Ramp XSlope (%) | 3.4 | | | |

**Remove & Replace Entire Ramp.**

Total Cost: \$ 1600.00
