# Access Compliance Report

## Public Rights-of-Way

### (Curb Ramps)

Intersection ID: 9073	Main Street: HUNTERS_CROSSING_LN	Cross Street: THE_PLAZA	Location: NW
ADA ID: 70E5EB1CF7C5	Ramp Type: BlendTrans2	Initial Pass/Fail: Fail	Overall Compliance: No
Severity Score: 10			
Codes/Mitigation Info/Possible Solution		Field Measurements/Component Compliance

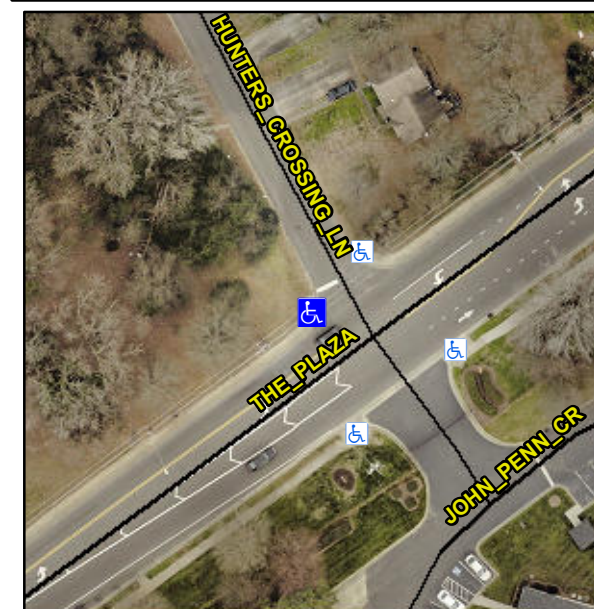
**NO RT SW**

**Not Found, R304.5.1, R304.5.3**

Compliance	Description	Data	Compliance	Description	Data
N/A	Ramp Length (in)	69.5	Yes	BlendTrans Slope (%)	2.9
No	Ramp Width (in)	47.0	No	BlendTrans XSlope (%)	4.5
N/A	Flare Type LT	N/A	N/A	Flare Type RT	N/A
N/A	Flare Slope LT (%)	N/A	N/A	Flare Slope RT (%)	N/A
N/A	Flare Traversable LT?	N/A	N/A	Flare Traversable RT?	N/A
N/A	Landing Length (in)	N/A	N/A	DWS Provided?	N/A
N/A	Landing Width (in)	N/A	N/A	DWS Contrast?	N/A
N/A	Landing Slope (%)	N/A	N/A	DWS Length (in)	N/A
N/A	Landing X Slope (%)	N/A	N/A	DWS Full Width?	N/A
N/A	Landing Curb? (Y/N)	N/A	N/A	DWS Offset (in)	N/A
N/A	Shared Landing?	N/A			
N/A	Gutter Ponding?	N/A	N/A	Gutter Slope (%)	N/A
N/A	Gutter Lip Ht (in)	1.0	N/A	Gutter X Slope (%)	N/A
N/A	Painted X Walk1?	No	N/A	Painted X Walk2?	No
	X Walk 1 Direction	To SE		X Walk 2 Direction	To NE
	X Walk 1 Width (in)	N/A		X Walk 2 Width (in)	N/A
	X Walk 1 Slope (%)	2.0		X Walk 2 Slope (%)	2.1
	X Walk 1 X Slope (%)	2.2		X Walk 2 X Slope (%)	1.6

N/A	Ramp inside XWalk1?	N/A	N/A	Ramp inside XWalk2?	N/A
	Road Slope (%)	2.4		Clear Space?	N/A
	Road X Slope (%)	0.0	N/A	Clear Space to XWalk (in)	N/A
N/A	Any Obstructions?	N/A	N/A	Storm Grate/Utility Hazard?	N/A
	Obstruction Type			Storm Grate/Utility Type	
		N/A			N/A
			Yes	Surface Condition? (G/P)	Good
			No	Curb Slope (%)	19.6

**Remove & Replace Curb Ramp With Two New Directional Ramps or Equivalent.**

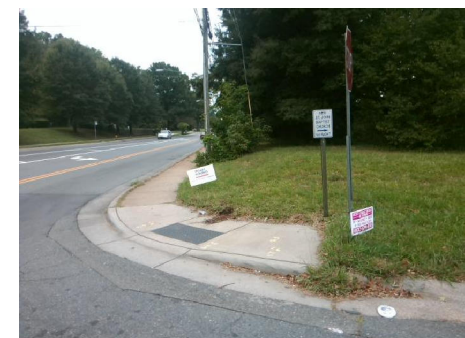
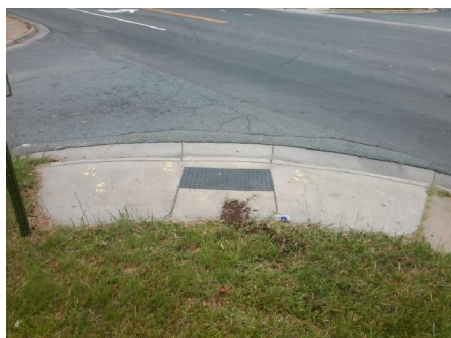
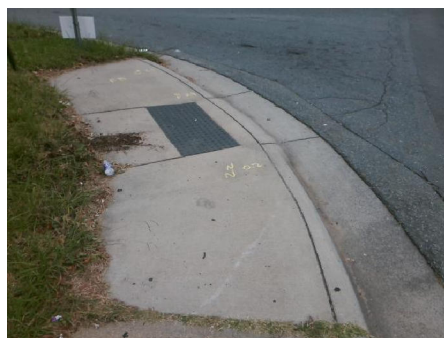
Street 1 Name THE PLAZA

Stop Condition-Street 1 None

Street 2 Name HUNTERS CROSSING LN

Stop Condition-Street 2 StopSign
