## Access Compliance Report Public Rights-of-Way (Curb Ramps)

| Intersection ID: 44760 | Main Street: KINGS_PARADE_BV | | | Street: | N/A | Location: | NW | | |
| ADA ID: 70F32D2DC5CF | A ID: 70F32D2DC5CF Ramp Type: Perp | | | Initial Pass/Fail: Fail Overall Compliance: No | | | | o Severity Score: | 12.5 |

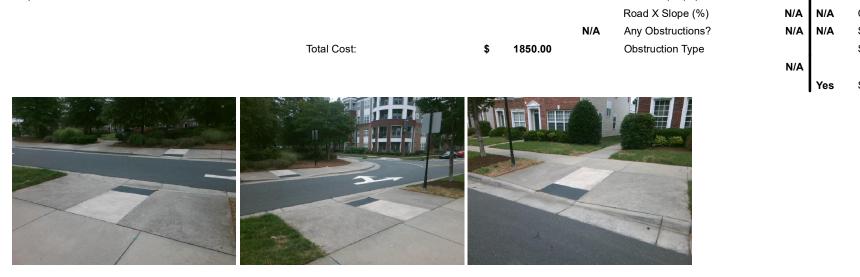
| Intersection ID: 44760 | Main Street: KINGS_PARADE_BV | | | Street: | N/A | Location: | NW | | |
|--|---|---|---|--|---|---|---|---|---|
| | A Republic | Remove & Replace Entire Ramp | | N/A | Ramp Length (in) | 97.0 | No | Ramp Slope (%) | 9.6 |

| Intersection ID: 44760 | Main Street: KINGS_PARADE_BV | | | Street: | N/A | Location: | NW | | |
|--|---|---|---|--|---|---|---|---|---|
| | | Total Cost: \$ | 1850.00 | | Obstruction Type | | | Storm Grate/Utility Type | |
