# Access Compliance Report

## Public Rights-of-Way

### (Curb Ramps)

Intersection ID: 10037285	Main Street: SARDIS_RD_NORTH	Cross Street: N/A	Location: NW
ADA ID: 70FE99670DDB	Ramp Type: Para	Initial Pass/Fail: Fail	Overall Compliance: No
		Severity Score: 12.5

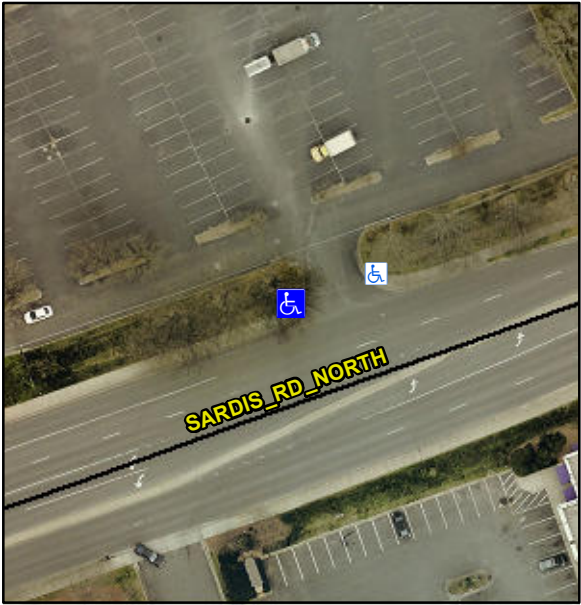
Possible Solutions:		<b>Compliance</b>	<b>Description</b>	<b>Data</b>
	<b>Remove &amp; Replace Entire Ramp.</b>		<b>N/A</b>	Ramp Length LT (in)	<b>45.0</b>
			<b>Yes</b>	Ramp Width LT (in)	<b>72.0</b>
			<b>No</b>	Ramp Slope LT (%)	<b>10.5</b>
			<b>Yes</b>	Ramp XSlope LT (%)	<b>1.0</b>
			<b>N/A</b>	Landing Length (in)	<b>N/A</b>
			<b>N/A</b>	Landing Width (in)	<b>N/A</b>
			<b>N/A</b>	Landing Slope (%)	<b>N/A</b>
			<b>N/A</b>	Landing X Slope (%)	<b>N/A</b>
			<b>N/A</b>	Landing Curb? (Y/N)	<b>N/A</b>
<p>Surveyor Notes:</p> <p><b>RT RP &lt; 5%</b></p> <p>PROW/ADA:</p> <p><b>R304.3.2</b></p>			<b>N/A</b>	Shared Landing?	<b>N/A</b>
			<b>N/A</b>	Gutter Ponding?	<b>N/A</b>
			<b>N/A</b>	Gutter Lip Ht (in)	<b>N/A</b>
			<b>N/A</b>	Painted X Walk1?	<b>No</b>
				X Walk 1 Direction	<b>To NE</b>
			<b>N/A</b>	X Walk 1 Width (in)	<b>N/A</b>

X Walk 1 Slope (%)	<b>0.3</b>
				X Walk 1 X Slope (%)	<b>1.9</b>
			<b>N/A</b>	Ramp inside XWalk1?	<b>N/A</b>
				Road Slope (%)	<b>N/A</b>
<p>Street 1 Name</p> <p>Stop Condition-Street 1</p> <p>Street 2 Name</p> <p>Stop Condition-Street 2</p>	<b>ENTRANCE</b>		<b>N/A</b>	Road X Slope (%)	<b>N/A</b>
	<b>StopSign</b>		<b>N/A</b>	Any Obstructions?	<b>N/A</b>
	<b>N/A</b>			Obstruction Type	
	<b>N/A</b>				
Total Cost:		<b>\$ 1600.00</b>	<b>N/A</b>		<b>N/A</b>
			<b>Yes</b>	Surface Condition? (G/P)	<b>Good</b>
			<b>N/A</b>	Curb Slope (%)	<b>10.9</b>
