Access Compliance Report

Public Rights-of-Way

(Curb Ramps)

Intersection ID: 11672	Main Street: CARTWRIGHT_PL	Cross Street: KEMPTON_PL	Location: NW
ADA ID: 710A3ABE6A4F	Ramp Type: Perp	Initial Pass/Fail: Pass	Overall Compliance: No
		Severity Score: 0

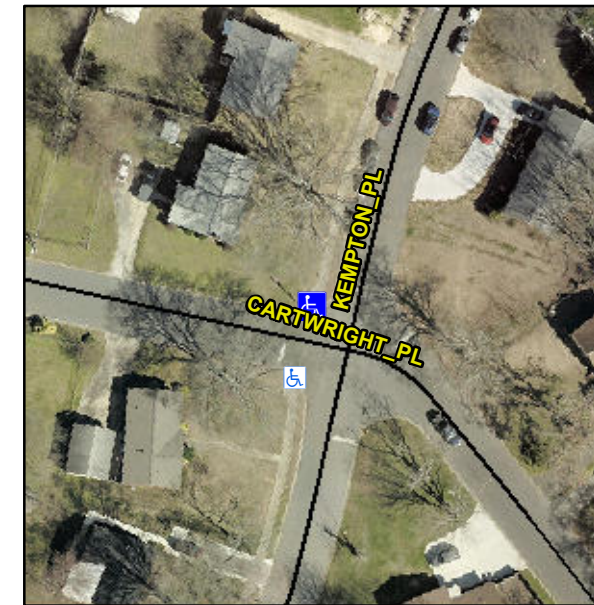
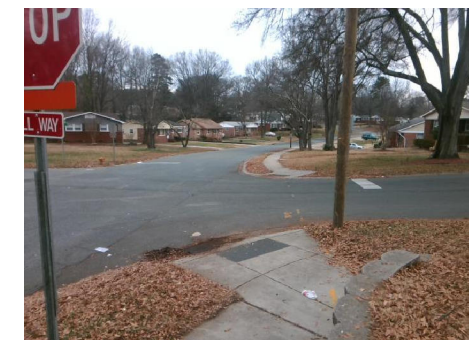
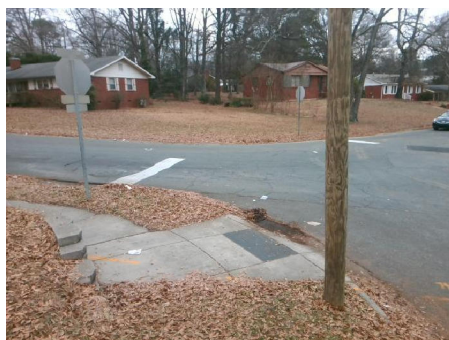
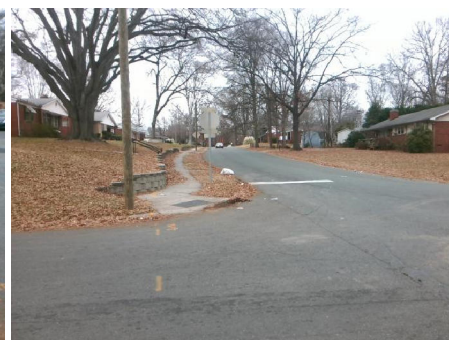
Not Found, R304.2.1

Compliance	Description	Data	Compliance	Description	Data
N/A	Ramp Length (in)	48.5	Yes	Ramp Slope (%)	7.0
Yes	Ramp Width (in)	48.0	Yes	Ramp XSlope (%)	0.5
N/A	Flare Type LT	Sloped	N/A	Flare Type RT	N/A
N/A	Flare Slope LT (%)	2.8	Yes	Flare Slope RT (%)	4.9
N/A	Flare Traversable LT?	No	N/A	Flare Traversable RT?	Yes
Yes	Landing Length (in)	61.5	Yes	DWS Provided?	Yes
No	Landing Width (in)	47.5	Yes	DWS Contrast?	Yes
Yes	Landing Slope (%)	1.5	Yes	DWS Length (in)	24.0
Yes	Landing X Slope (%)	0.1	Yes	DWS Full Width?	Yes
N/A	Landing Curb? (Y/N)	No	Yes	DWS Offset (in)	0.0
N/A	Shared Landing?	No			
Yes	Gutter Ponding?	No	Yes	Gutter Slope (%)	4.4
Yes	Gutter Lip Ht (in)	0.0	Yes	Gutter X Slope (%)	0.9
N/A	Painted X Walk1?	No	N/A	Painted X Walk2?	N/A
	X Walk 1 Direction	To SW		X Walk 2 Direction	N/A
N/A	X Walk 1 Width (in)	N/A	N/A	X Walk 2 Width (in)	N/A
	X Walk 1 Slope (%)	5.6		X Walk 2 Slope (%)	N/A
	X Walk 1 X Slope (%)	1.7		X Walk 2 X Slope (%)	N/A

N/A	Ramp inside XWalk1?	N/A	N/A	Ramp inside XWalk2?	N/A
	Road Slope (%)	N/A	N/A	Clear Space?	Yes
	Road X Slope (%)	N/A	N/A	Clear Space to XWalk (in)	N/A
Yes	Any Obstructions?	No	Yes	Storm Grate/Utility Hazard?	No
	Obstruction Type			Storm Grate/Utility Type	
		N/A			N/A
			Yes	Surface Condition? (G/P)	Good

Remove & Replace Entire Ramp.
