# Access Compliance Report

## Public Rights-of-Way

### (Curb Ramps)

Intersection ID: 14535	Main Street: E_KINGSTON_AV	Cross Street: LENNOX_AV	Location: S
ADA ID: 71257009DA66	Ramp Type: Perp	Initial Pass/Fail: Fail	Overall Compliance: No
Codes/Mitigation Info/Possible Solution		Field Measurements/Component Compliance	
Severity Score: 28.75

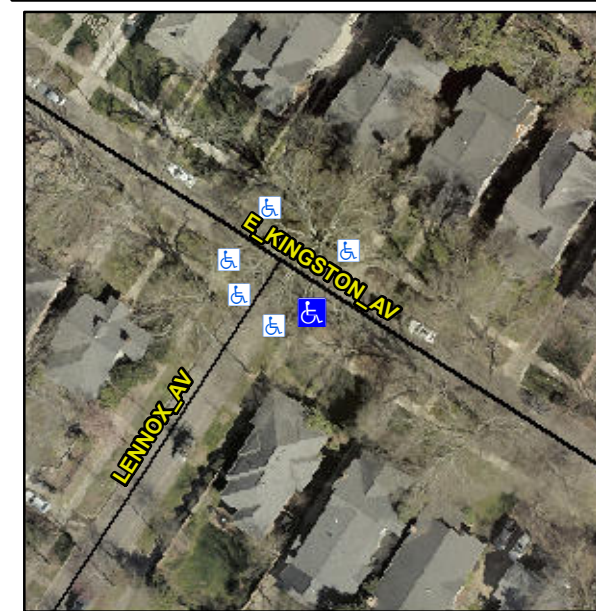
**Not Found, R304.2.2, R302.7**

Compliance	Description	Data	Compliance	Description	Data
N/A	Ramp Length (in)	72.0	No	Ramp Slope (%)	9.4
Yes	Ramp Width (in)	48.0	Yes	Ramp XSlope (%)	2.1
N/A	Flare Type LT	N/A	N/A	Flare Type RT	N/A
N/A	Flare Slope LT (%)	N/A	N/A	Flare Slope RT (%)	N/A
N/A	Flare Traversable LT?	N/A	N/A	Flare Traversable RT?	N/A
N/A	Landing Length (in)	N/A	N/A	DWS Provided?	N/A
N/A	Landing Width (in)	N/A	N/A	DWS Contrast?	N/A
N/A	Landing Slope (%)	N/A	N/A	DWS Length (in)	N/A
N/A	Landing X Slope (%)	N/A	N/A	DWS Full Width?	N/A
N/A	Landing Curb? (Y/N)	N/A	N/A	DWS Offset (in)	N/A
N/A	Shared Landing?	N/A			
N/A	Gutter Ponding?	N/A	N/A	Gutter Slope (%)	N/A
N/A	Gutter Lip Ht (in)	1.0	N/A	Gutter X Slope (%)	N/A
N/A	Painted X Walk1?	No	N/A	Painted X Walk2?	N/A
	X Walk 1 Direction	To NE		X Walk 2 Direction	N/A
N/A	X Walk 1 Width (in)	N/A	N/A	X Walk 2 Width (in)	N/A
	X Walk 1 Slope (%)	5.3		X Walk 2 Slope (%)	N/A
	X Walk 1 X Slope (%)	3.3		X Walk 2 X Slope (%)	N/A

N/A	Ramp inside XWalk1?	N/A	N/A	Ramp inside XWalk2?	N/A
	Road Slope (%)	N/A	N/A	Clear Space?	N/A
	Road X Slope (%)	N/A	N/A	Clear Space to XWalk (in)	N/A
N/A	Any Obstructions?	N/A	N/A	Storm Grate/Utility Hazard?	N/A
	Obstruction Type			Storm Grate/Utility Type	
		N/A			N/A
		No		Surface Condition? (G/P)	Poor

**Remove & Replace Entire Ramp.**

Total Cost: \$ 1850.00
