Access Compliance Report

Public Rights-of-Way

(Curb Ramps)

Intersection ID: N/A	Main Street: SOLAR_WY	Cross Street: ROCK_ISLAND_RD	Location: NW
ADA ID: 7136F951CF97	Ramp Type: Perp	Initial Pass/Fail: Fail	Overall Compliance: No
Severity Score: 22.5			
Codes/Mitigation Info/Possible Solution		Field Measurements/Component Compliance

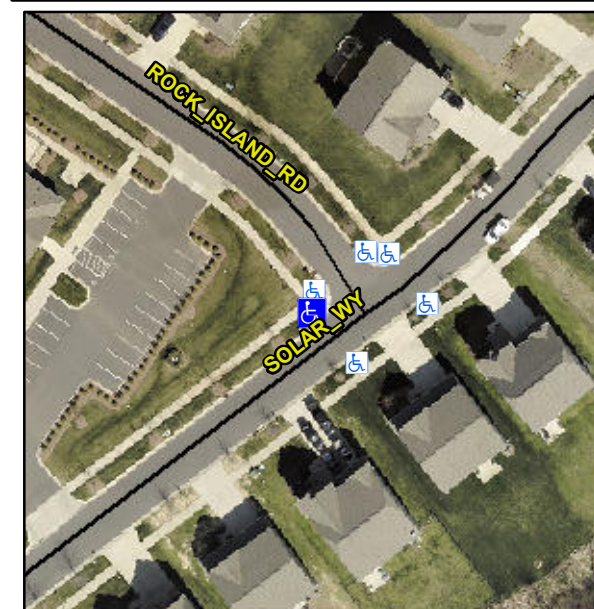
Not Found, R304.5.1, R304.2.2

Compliance	Description	Data	Compliance	Description	Data
N/A	Ramp Length (in)	105.0	No	Ramp Slope (%)	9.3
No	Ramp Width (in)	46.5	Yes	Ramp XSlope (%)	3.3
N/A	Flare Type LT	N/A	N/A	Flare Type RT	N/A
N/A	Flare Slope LT (%)	N/A	N/A	Flare Slope RT (%)	N/A
N/A	Flare Traversable LT?	N/A	N/A	Flare Traversable RT?	N/A
N/A	Landing Length (in)	N/A	N/A	DWS Provided?	N/A
N/A	Landing Width (in)	N/A	N/A	DWS Contrast?	N/A
N/A	Landing Slope (%)	N/A	N/A	DWS Length (in)	N/A
N/A	Landing X Slope (%)	N/A	N/A	DWS Full Width?	N/A
N/A	Landing Curb? (Y/N)	N/A	N/A	DWS Offset (in)	N/A
N/A	Shared Landing?	N/A			
N/A	Gutter Ponding?	N/A	N/A	Gutter Slope (%)	N/A
N/A	Gutter Lip Ht (in)	N/A	N/A	Gutter X Slope (%)	N/A
N/A	Painted X Walk1?	No	N/A	Painted X Walk2?	N/A
	X Walk 1 Direction	To SE		X Walk 2 Direction	N/A
N/A	X Walk 1 Width (in)	N/A	N/A	X Walk 2 Width (in)	N/A
	X Walk 1 Slope (%)	3.2		X Walk 2 Slope (%)	N/A
	X Walk 1 X Slope (%)	3.4		X Walk 2 X Slope (%)	N/A

Remove & Replace Entire Ramp.

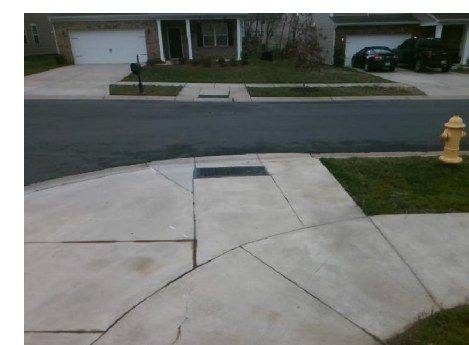
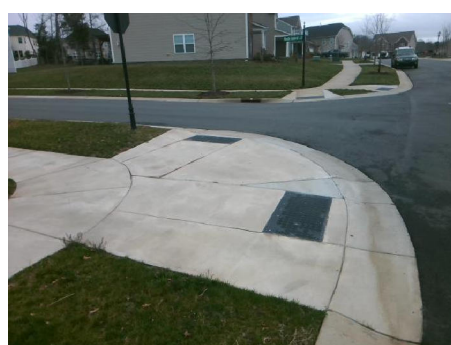
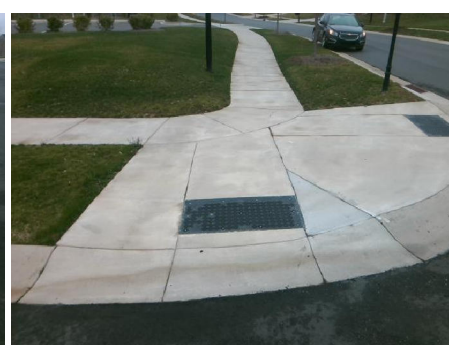
N/A	Ramp inside XWalk1?	N/A	N/A	Ramp inside XWalk2?	N/A
	Road Slope (%)	N/A	N/A	Clear Space?	N/A
	Road X Slope (%)	N/A	N/A	Clear Space to XWalk (in)	N/A
N/A	Any Obstructions?	N/A	N/A	Storm Grate/Utility Hazard?	N/A
	Obstruction Type			Storm Grate/Utility Type	
		N/A			N/A
			Yes	Surface Condition? (G/P)	Good
