Access Compliance Report Public Rights-of-Way (Curb Ramps)

Intersection ID: 15280 Main Street: DILWORTH RD EAST **Cross Street: DILWORTH RD WEST** Location: SE Ramp Type: PerpDiag Initial Pass/Fail: Pass **Overall Compliance: No Severity Score:** 25 **ADA ID: 713F16ACDF65**

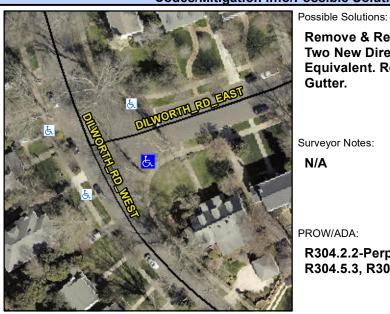
Compliance Description Date		Data	Compliance Description		Data
N/A	Ramp Length (in)	51.0	Yes	Ramp Slope (%)	7.2
Yes	Ramp Width (in)	48.0	Yes	Ramp XSlope (%)	1.2
N/A	Flare Type LT	Sloped	N/A	Flare Type RT	N/A
N/A	Flare Slope LT (%)	11.4	N/A	Flare Slope RT (%)	5.9
N/A	Flare Traversable LT?	No	N/A	Flare Traversable RT?	No
Yes	Landing Length (in)	48.0	No	DWS Provided?	No
Yes	Landing Width (in)	48.0	N/A	DWS Contrast?	No
No	Landing Slope (%)	2.4	N/A	DWS Length (in)	N/A
No	Landing X Slope (%)	2.1	N/A	DWS Full Width?	No
N/A	Landing Curb? (Y/N)	No	N/A	DWS Offset (in)	N/A
N/A	Shared Landing?	No			
Yes	Gutter Ponding?	No	Yes	Gutter Slope (%)	3.4
No	Gutter Lip Ht (in)	1.0	No	Gutter X Slope (%)	2.3
N/A	Painted X Walk1?	No	N/A	Painted X Walk2?	No
	X Walk 1 Direction	To N		X Walk 2 Direction	To W
N/A	X Walk 1 Width (in)	N/A	N/A	X Walk 2 Width (in)	N/A
	X Walk 1 Slope (%)	4.9		X Walk 2 Slope (%)	2.4
	X Walk 1 X Slope (%)	0.6		X Walk 2 X Slope (%)	5.5

N/A	Ramp inside XWalk1?	N/A	N/A	Ramp inside XWalk2?	N/A
	Road Slope (%)	1.7	N/A	Clear Space?	Yes
	Road X Slope (%)	5.1	N/A	Clear Space to XWalk (in)	N/A
Yes	Any Obstructions?	No	Yes	Storm Grate/Utility Hazard?	No
	Obstruction Type			Storm Grate/Utility Type	
		N/A			N/A
			Yes	Surface Condition? (G/P)	Good

Remove & Replace Curb Ramp With Two New Directional Ramps or Equivalent. Remove & Replace Gutter.

R304.2.2-Perp, R304.3.2-Para, R304.5.3, R305, R302.7.2
