Access Compliance Report

Public Rights-of-Way

(Curb Ramps)

| Intersection ID: 13714 | Main Street: HANOVER_ST | Cross Street: MCCLINTOCK_RD | Location: NW |

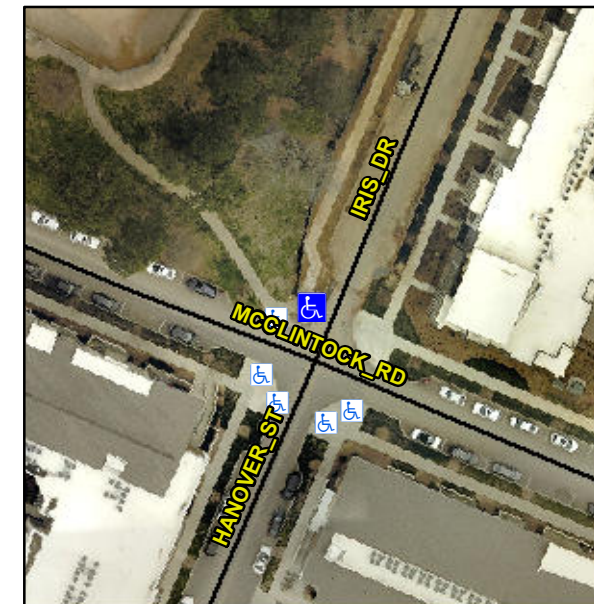
| ADA ID: 7140DC1667E0 | Ramp Type: Perp | Initial Pass/Fail: Fail | Overall Compliance: No |
| | | | Severity Score: 13.75 |

Not Found, R304.2.2, R304.5.3

| Compliance | Description | Data | Compliance | Description | Data |
|---|---|---|---|---|---|
| N/A | Ramp Length (in) | 73.0 | No | Ramp Slope (%) | 8.5 |
| Yes | Ramp Width (in) | 48.0 | No | Ramp XSlope (%) | 4.3 |

Possible Solutions:

Remove & Replace Entire Ramp.

Total Cost: \$ 1850.00
