Access Compliance Report

Public Rights-of-Way (Curb Ramps)

| Intersection ID: 49251 | Main Street: RIDGE_PATH_LN | Cross Street: PROSPERITY_RIDGE_RD | Location: W |
| ADA ID: 715AB0D8550D | Ramp Type: Perp | Initial Pass/Fail: Pass | Overall Compliance: No |

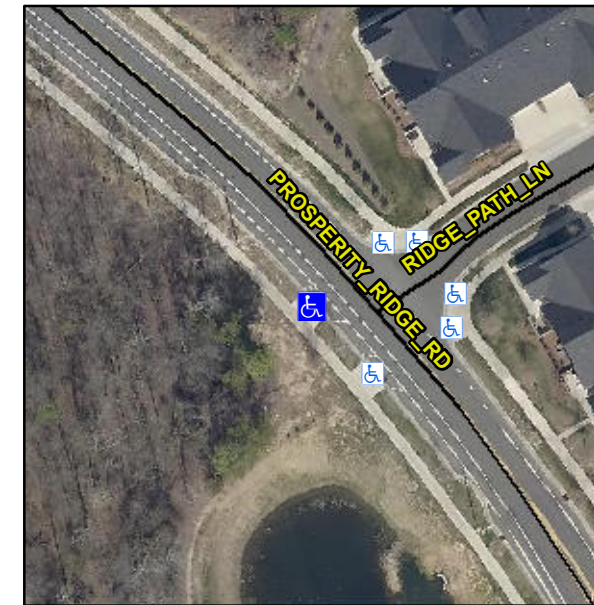
R304.2.3

| Compliance | Description | Data | Compliance | Description | Data |
|---|---|---|---|---|---|
| N/A | Flare Slope LT (%) | 2.6 | No | Flare Slope RT (%) | 11.2 |

Remove & Replace Flare.
