Access Compliance Report

Public Rights-of-Way

(Curb Ramps)

Intersection ID: 4398	Main Street: AMARANTHUS_CT	Cross Street: BROOKSTONE_DR	Location: SW
ADA ID: 715DDDDC0877	Ramp Type: Perp	Initial Pass/Fail: Fail	Overall Compliance: No
Severity Score: 36.25			
Codes/Mitigation Info/Possible Solution		Field Measurements/Component Compliance

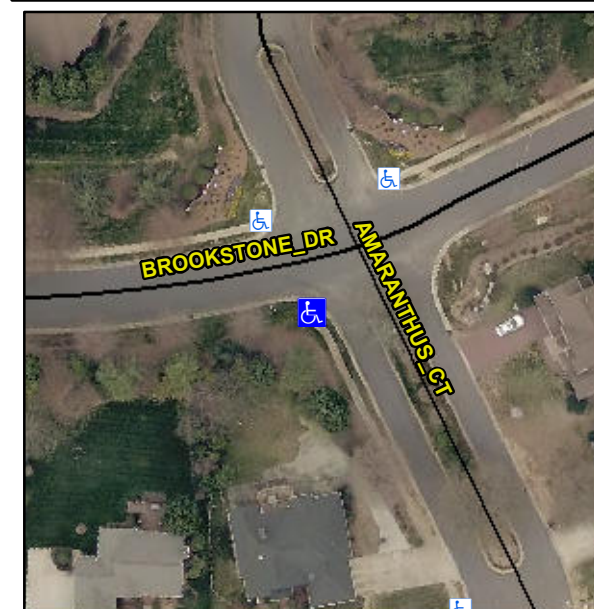
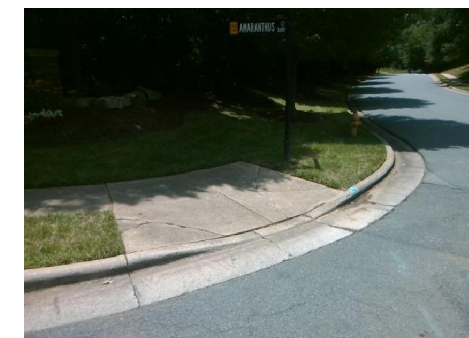
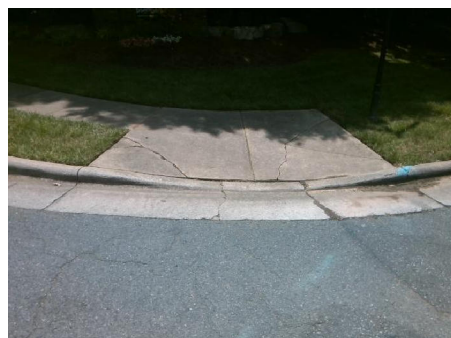
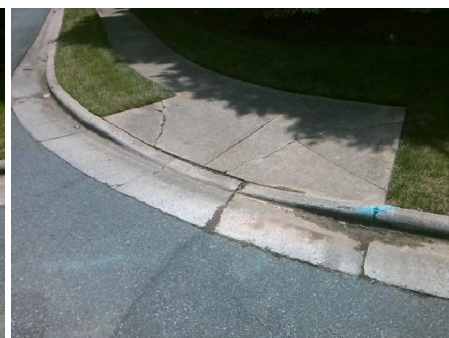
Not Found, R304.5.1, R304.5.3, R302.7

Compliance	Description	Data	Compliance	Description	Data
N/A	Ramp Length (in)	50.0	Yes	Ramp Slope (%)	6.4
No	Ramp Width (in)	37.0	No	Ramp XSlope (%)	5.7
N/A	Flare Type LT	N/A	N/A	Flare Type RT	N/A
N/A	Flare Slope LT (%)	N/A	N/A	Flare Slope RT (%)	N/A
N/A	Flare Traversable LT?	N/A	N/A	Flare Traversable RT?	N/A
N/A	Landing Length (in)	N/A	N/A	DWS Provided?	N/A
N/A	Landing Width (in)	N/A	N/A	DWS Contrast?	N/A
N/A	Landing Slope (%)	N/A	N/A	DWS Length (in)	N/A
N/A	Landing X Slope (%)	N/A	N/A	DWS Full Width?	N/A
N/A	Landing Curb? (Y/N)	N/A	N/A	DWS Offset (in)	N/A
N/A	Shared Landing?	N/A			
N/A	Gutter Ponding?	N/A	N/A	Gutter Slope (%)	N/A
N/A	Gutter Lip Ht (in)	N/A	N/A	Gutter X Slope (%)	N/A
N/A	Painted X Walk1?	No	N/A	Painted X Walk2?	N/A
	X Walk 1 Direction	To N		X Walk 2 Direction	N/A
N/A	X Walk 1 Width (in)	N/A	N/A	X Walk 2 Width (in)	N/A
	X Walk 1 Slope (%)	3.7		X Walk 2 Slope (%)	N/A
	X Walk 1 X Slope (%)	3.5		X Walk 2 X Slope (%)	N/A

N/A	Ramp inside XWalk1?	N/A	N/A	Ramp inside XWalk2?	N/A
	Road Slope (%)	N/A	N/A	Clear Space?	N/A
	Road X Slope (%)	N/A	N/A	Clear Space to XWalk (in)	N/A
N/A	Any Obstructions?	N/A	N/A	Storm Grate/Utility Hazard?	N/A
	Obstruction Type			Storm Grate/Utility Type	
		N/A			N/A
		No		Surface Condition? (G/P)	Poor

Remove & Replace Entire Ramp.
