## **Access Compliance Report Public Rights-of-Way** (Curb Ramps)

Intersection ID: 10022634 Main Street: CARMEL RD **Cross Street: N/A** Location: NE Initial Pass/Fail: Fail ADA ID: 71614AEF759B Ramp Type: PerpDiag **Overall Compliance: No** Severity Score: 21.25

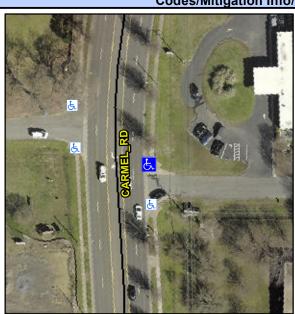
Field Measurements/Component Compliance						
Compliance Description		Data	Compl	iance	Description	Data
N/A	Ramp Length (in)	56.0	Yes Ramp Slope (%)		5.3	
No	Ramp Width (in)	40.0	No	Ramp XSlope (%)		5.8
N/A	Flare Type LT	N/A	N/A	Flare Type RT		N/A
N/A	Flare Slope LT (%)	N/A	N/A	Flare Slope RT (%)		N/A
N/A	Flare Traversable LT?	N/A	N/A	Flare	Traversable RT?	N/A
N/A	Landing Length (in)	N/A	N/A	DWS	Provided?	N/A
N/A	Landing Width (in)	N/A	N/A	DWS	Contrast?	N/A
N/A	Landing Slope (%)	N/A	N/A	DWS	Length (in)	N/A
N/A	Landing X Slope (%)	N/A	N/A	DWS	Full Width?	N/A
N/A	Landing Curb? (Y/N)	N/A	N/A	DWS	Offset (in)	N/A
N/A	Shared Landing?	N/A				
N/A	Gutter Ponding?	N/A	N/A	Gutte	r Slope (%)	N/A
N/A	Gutter Lip Ht (in)	N/A	N/A	Gutte	r X Slope (%)	N/A
N/A	Painted X Walk1?	No	N/A	Paint	ed X Walk2?	No
	X Walk 1 Direction	To W		X Wa	lk 2 Direction	To SW
N/A	X Walk 1 Width (in)	N/A	N/A	X Wa	lk 2 Width (in)	N/A
	X Walk 1 Slope (%)	5.0		X Wa	lk 2 Slope (%)	3.7

X Walk 1 X Slope (%)	2.9		X Wa	lk 2 X Slope (%)	7.0
N/A	Ramp inside XWalk1?	N/A	N/A	Ramp	inside XWalk2?	N/A
	Road Slope (%)	1.9	N/A	Clear	Space?	N/A
	Road X Slope (%)	5.8	N/A	Clear	Space to XWalk (in)	N/A
N/A	Any Obstructions?	N/A	N/A	Storm	Grate/Utility Hazard?	N/A
	Obstruction Type			Storm	Grate/Utility Type	
		N/A				N/A
			Yes	Surfa	ce Condition? (G/P)	Good
10,47,9800 /60

Street 1 Name **CARMEL RD** Stop Condition-Street 2 None Street 2 Name **ENTRANCE** Stop Condition-Street 1 None Possible Solutions: Remove & Replace Curb Ramp With **Two New Directional Ramps or** Equivalent. Surveyor Notes: N/A PROW/ADA: R304.5.1, R304.5.3
