## Access Compliance Report Public Rights-of-Way (Curb Ramps)

Intersection ID: 21728Main Street:BRYNHURST\_DRCross Street:WATERCREST\_RDLocation:SWADA ID: 7167D3EF3803Ramp Type:PerpDiagInitial Pass/Fail:FailOverall Compliance:NoSeverity Score:25

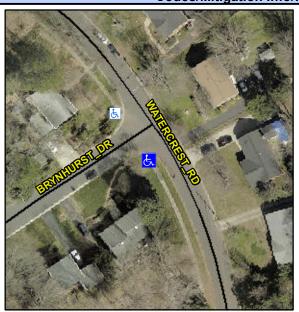
PROW/ADA:
Not Found, R304.5.3

| Compliance Description | | Data | Comp | liance Description | Data |
|---|---|---|---|---|---|
| Yes | Ramp Width (in) | 48.0 | No | Ramp XSlope (%) | 12.9 |

Remove & Replace Curb Ramp With
Two New Directional Ramps or
Equivalent.
