Access Compliance Report

Public Rights-of-Way

(Curb Ramps)

Intersection ID: 7616	Main Street: GEORGETOWN_DR	Cross Street: SPRING_GARDEN_LN	Location: SW
ADA ID: 717033CD1DAB	Ramp Type: Perp	Initial Pass/Fail: Fail	Overall Compliance: No
Severity Score: 21.25			
Codes/Mitigation Info/Possible Solution		Field Measurements/Component Compliance

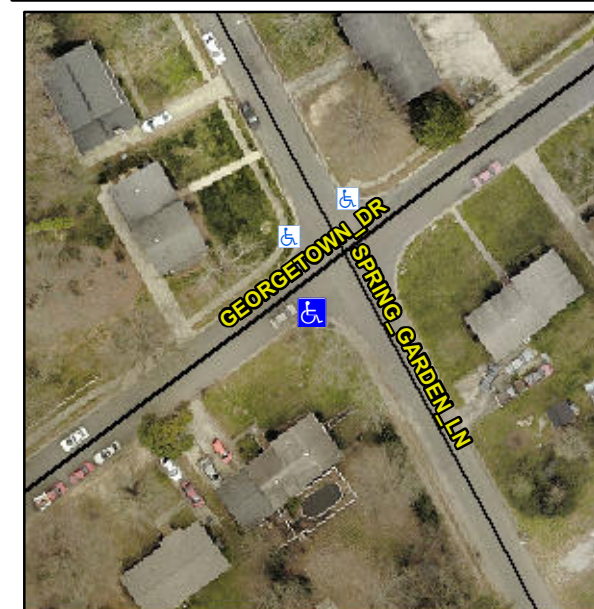
Not Found, R304.5.1, R304.2.2

Compliance	Description	Data	Compliance	Description	Data
N/A	Ramp Length (in)	47.5	No	Ramp Slope (%)	10.8
No	Ramp Width (in)	42.0	Yes	Ramp XSlope (%)	0.6
N/A	Flare Type LT	N/A	N/A	Flare Type RT	N/A
N/A	Flare Slope LT (%)	N/A	N/A	Flare Slope RT (%)	N/A
N/A	Flare Traversable LT?	N/A	N/A	Flare Traversable RT?	N/A
N/A	Landing Length (in)	N/A	N/A	DWS Provided?	N/A
N/A	Landing Width (in)	N/A	N/A	DWS Contrast?	N/A
N/A	Landing Slope (%)	N/A	N/A	DWS Length (in)	N/A
N/A	Landing X Slope (%)	N/A	N/A	DWS Full Width?	N/A
N/A	Landing Curb? (Y/N)	N/A	N/A	DWS Offset (in)	N/A
N/A	Shared Landing?	N/A			
N/A	Gutter Ponding?	N/A	N/A	Gutter Slope (%)	N/A
N/A	Gutter Lip Ht (in)	0.5	N/A	Gutter X Slope (%)	N/A
N/A	Painted X Walk1?	No	N/A	Painted X Walk2?	N/A
	X Walk 1 Direction	To NW		X Walk 2 Direction	N/A
N/A	X Walk 1 Width (in)	N/A	N/A	X Walk 2 Width (in)	N/A
	X Walk 1 Slope (%)	0.0		X Walk 2 Slope (%)	N/A
	X Walk 1 X Slope (%)	3.1		X Walk 2 X Slope (%)	N/A

N/A	Ramp inside XWalk1?	N/A	N/A	Ramp inside XWalk2?	N/A
	Road Slope (%)	N/A	N/A	Clear Space?	N/A
	Road X Slope (%)	N/A	N/A	Clear Space to XWalk (in)	N/A
N/A	Any Obstructions?	N/A	N/A	Storm Grate/Utility Hazard?	N/A
	Obstruction Type			Storm Grate/Utility Type	
		N/A			N/A
			Yes	Surface Condition? (G/P)	Good

Possible Solutions:

Remove & Replace Entire Ramp.
