Access Compliance Report

Public Rights-of-Way

(Curb Ramps)

Intersection ID: 14505	Main Street: REMOUNT_RD	Cross Street: REMUS_RD	Location: NE
ADA ID: 7188186B0C36	Ramp Type: PerpDiag	Initial Pass/Fail: Fail	Overall Compliance: No
Severity Score: 35			
Codes/Mitigation Info/Possible Solution		Field Measurements/Component Compliance

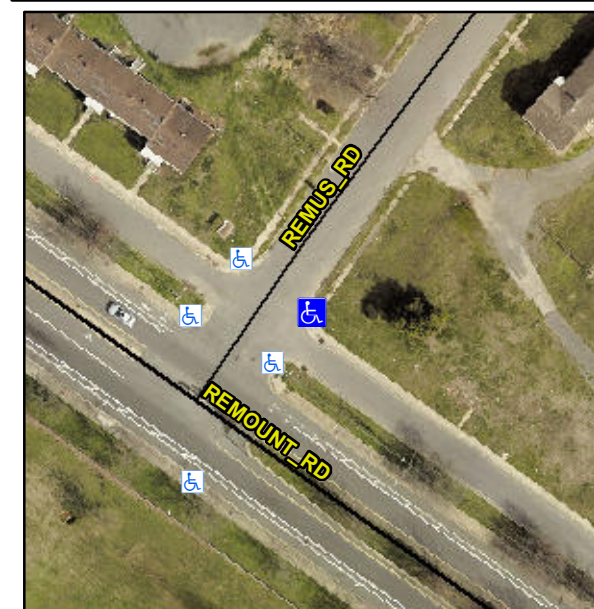
Not Found, R304.5.1

Compliance	Description	Data	Compliance	Description	Data
N/A	Ramp Length (in)	64.0	Yes	Ramp Slope (%)	6.7
No	Ramp Width (in)	25.0	Yes	Ramp XSlope (%)	0.1
N/A	Flare Type LT	N/A	N/A	Flare Type RT	N/A
N/A	Flare Slope LT (%)	N/A	N/A	Flare Slope RT (%)	N/A
N/A	Flare Traversable LT?	N/A	N/A	Flare Traversable RT?	N/A
N/A	Landing Length (in)	N/A	N/A	DWS Provided?	N/A
N/A	Landing Width (in)	N/A	N/A	DWS Contrast?	N/A
N/A	Landing Slope (%)	N/A	N/A	DWS Length (in)	N/A
N/A	Landing X Slope (%)	N/A	N/A	DWS Full Width?	N/A
N/A	Landing Curb? (Y/N)	N/A	N/A	DWS Offset (in)	N/A
N/A	Shared Landing?	N/A			
N/A	Gutter Ponding?	N/A	N/A	Gutter Slope (%)	N/A
N/A	Gutter Lip Ht (in)	N/A	N/A	Gutter X Slope (%)	N/A
N/A	Painted X Walk1?	No	N/A	Painted X Walk2?	No
	X Walk 1 Direction	To NW		X Walk 2 Direction	To SW
N/A	X Walk 1 Width (in)	N/A	N/A	X Walk 2 Width (in)	N/A
	X Walk 1 Slope (%)	0.7		X Walk 2 Slope (%)	0.3
	X Walk 1 X Slope (%)	0.7		X Walk 2 X Slope (%)	0.6

N/A	Ramp inside XWalk1?	N/A	N/A	Ramp inside XWalk2?	N/A
	Road Slope (%)	0.0	N/A	Clear Space?	N/A
	Road X Slope (%)	0.6	N/A	Clear Space to XWalk (in)	N/A
N/A	Any Obstructions?	N/A	N/A	Storm Grate/Utility Hazard?	N/A
	Obstruction Type			Storm Grate/Utility Type	
		N/A			N/A
			Yes	Surface Condition? (G/P)	Good

Remove & Replace Curb Ramp With Two New Directional Ramps or Equivalent.
