# Access Compliance Report

## Public Rights-of-Way

### (Curb Ramps)

| Intersection ID: 10020349 | Main Street: BALLANTYNE COMMONS PY | Cross Street: N/A | Location: NW |

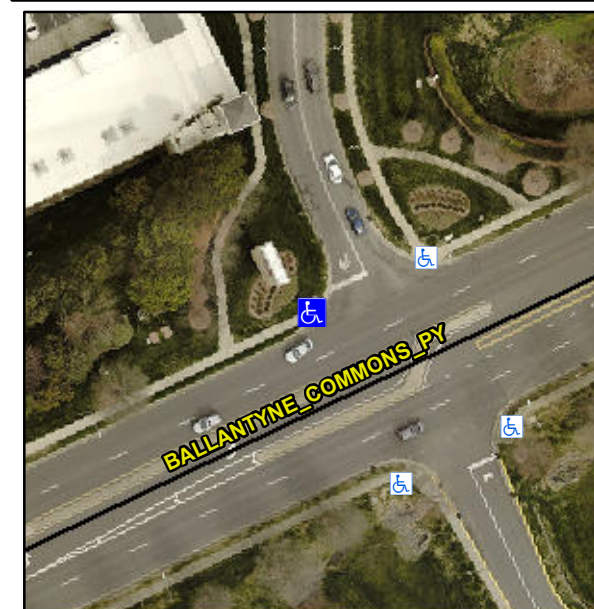
| Severity Score: 33.75 | | | |

**Not Found, R304.5.1, R304.2.2**

| Compliance | Description | Data | Compliance | Description | Data |
|---|---|---|---|---|---|
| N/A | Ramp Length (in) | 64.0 | No | Ramp Slope (%) | 13.2 |
| No | Ramp Width (in) | 47.0 | Yes | Ramp XSlope (%) | 0.2 |

**Remove & Replace Entire Ramp.**
