Access Compliance Report

Public Rights-of-Way

(Curb Ramps)

Intersection ID: 19121		Main Street: MILLBURY_CT		Cross Street: RAMA_RD		Location: NE			
ADA ID: 719B18D26FF4		Ramp Type: PerpDiag		Initial Pass/Fail: Fail		Overall Compliance: No		Severity Score: 25	
Codes/Mitigation Info/Possible Solution					Field Measurements/Component Compliance

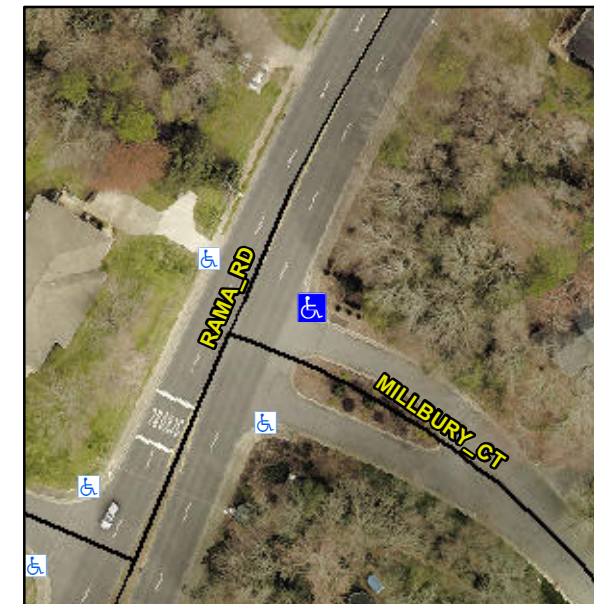
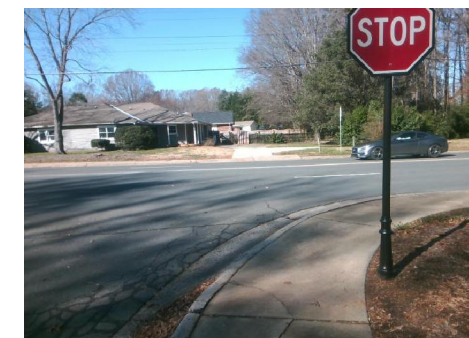
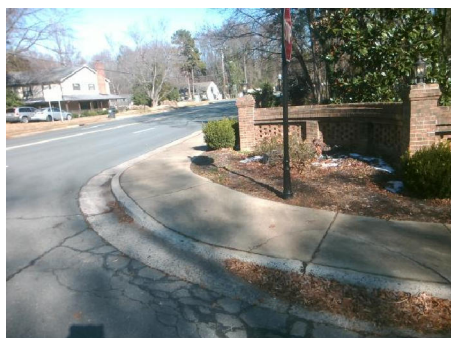
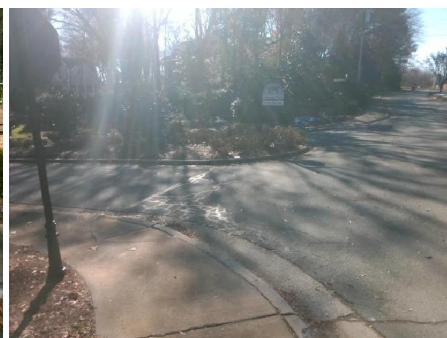
Compliance	Description	Data	Compliance	Description	Data
N/A	Ramp Length (in)	60.5	Yes	Ramp Slope (%)	7.3
Yes	Ramp Width (in)	48.0	No	Ramp XSlope (%)	7.6
N/A	Flare Type LT	N/A	N/A	Flare Type RT	N/A
N/A	Flare Slope LT (%)	N/A	N/A	Flare Slope RT (%)	N/A
N/A	Flare Traversable LT?	N/A	N/A	Flare Traversable RT?	N/A
N/A	Landing Length (in)	N/A	N/A	DWS Provided?	N/A
N/A	Landing Width (in)	N/A	N/A	DWS Contrast?	N/A
N/A	Landing Slope (%)	N/A	N/A	DWS Length (in)	N/A
N/A	Landing X Slope (%)	N/A	N/A	DWS Full Width?	N/A
N/A	Landing Curb? (Y/N)	N/A	N/A	DWS Offset (in)	N/A
N/A	Shared Landing?	N/A			
N/A	Gutter Ponding?	N/A	N/A	Gutter Slope (%)	N/A
N/A	Gutter Lip Ht (in)	N/A	N/A	Gutter X Slope (%)	N/A
N/A	Painted X Walk1?	No	N/A	Painted X Walk2?	No
	X Walk 1 Direction	To NW		X Walk 2 Direction	To SW
N/A	X Walk 1 Width (in)	N/A	N/A	X Walk 2 Width (in)	N/A
	X Walk 1 Slope (%)	4.7		X Walk 2 Slope (%)	2.2
	X Walk 1 X Slope (%)	2.3		X Walk 2 X Slope (%)	5.1

N/A	Ramp inside XWalk1?	N/A	N/A	Ramp inside XWalk2?	N/A
	Road Slope (%)	2.7	N/A	Clear Space?	N/A
	Road X Slope (%)	4.3	N/A	Clear Space to XWalk (in)	N/A
N/A	Any Obstructions?	N/A	N/A	Storm Grate/Utility Hazard?	N/A
	Obstruction Type			Storm Grate/Utility Type	
		N/A			N/A
			Yes	Surface Condition? (G/P)	Good

Remove & Replace Curb Ramp With Two New Directional Ramps or Equivalent.

Total Cost: \$ 3200.00
