# Access Compliance Report

## Public Rights-of-Way

### (Curb Ramps)

| Intersection ID: 11157 | Main Street: N_IRWIN_AV | Cross Street: W_6TH_ST | Location: W |

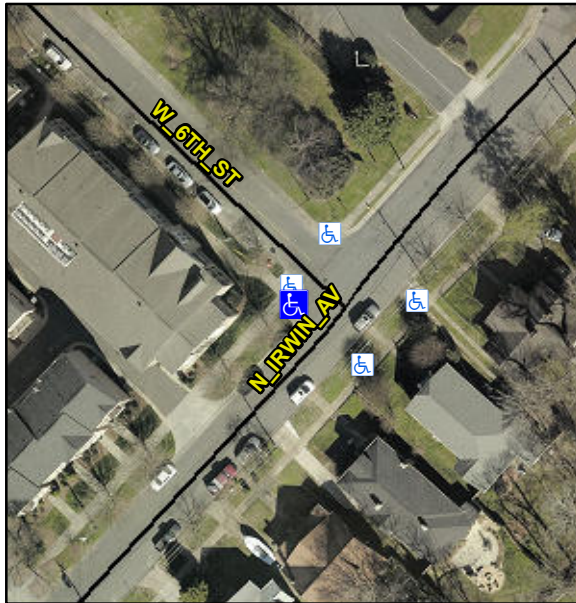
**R304.5.3**

| Compliance | Description | Data | Compliance | Description | Data |
|---|---|---|---|---|---|
| N/A | Ramp Length (in) | 62.0 | Yes | Grade Break? | Yes |
| Yes | Ramp Width (in) | 72.0 | Yes | Grade Break Slope (%) | 3.2 |
| Yes | Ramp Slope (%) | 1.2 | No | Grade Break XSlope (%) | 3.4 |
| No | Ramp XSlope (%) | 2.5 | | | |

**Remove & Replace Entire Ramp.  
Remove & Replace Gutter.**

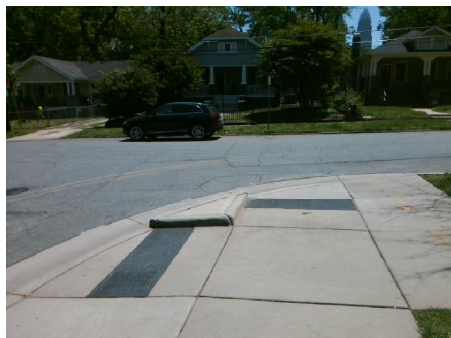
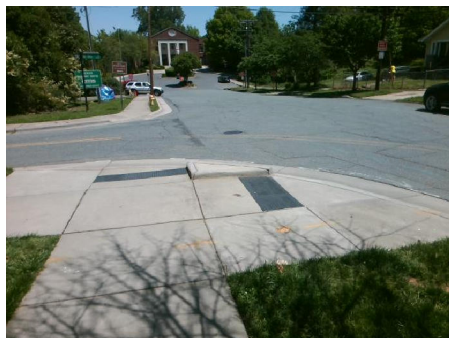
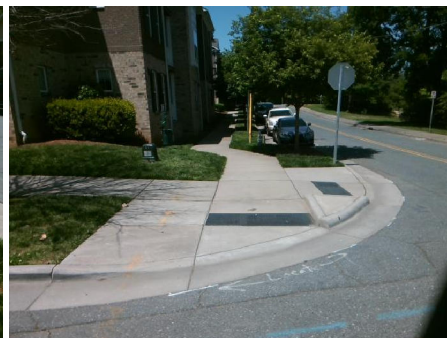
| Compliance | Description | Data | Compliance | Description | Data |
|---|---|---|---|---|---|
| No | Landing X Slope (%) | 2.3 | Yes | DWS Full Width? | Yes |
| Yes | Gutter Lip Ht (in) | 0.0 | No | Gutter X Slope (%) | 4.1 |
