Access Compliance Report Public Rights-of-Way (Curb Ramps)

Intersection ID: 15273 Main Street: E_INDEPENDENCE_BV Cross Street: NORLAND_RD Location: NW

ADA ID: 71CD4BD38B92 Ramp Type: Perp Initial Pass/Fail: Fail Overall Compliance: No Severity Score: 21.25

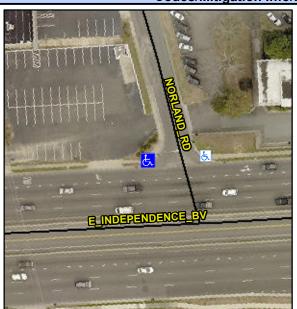
Field Measurements/Component Compliance							
Comp	liance Description	Data	Comp	liance Description	Data		
N/A	Ramp Length (in)	89.0	Yes	Ramp Slope (%)	7.7		
No	Ramp Width (in)	41.0	No	Ramp XSlope (%)	5.4		
N/A	Flare Type LT	N/A	N/A	Flare Type RT	N/A		
N/A	Flare Slope LT (%)	N/A	N/A	Flare Slope RT (%)	N/A		
N/A	Flare Traversable LT?	N/A	N/A Flare Traversable RT?		N/A		
N/A	Landing Length (in)	N/A	N/A	DWS Provided?	N/A		
N/A	Landing Width (in)	N/A	N/A	DWS Contrast?	N/A		
N/A	Landing Slope (%)	N/A	N/A	DWS Length (in)	N/A		
N/A	Landing X Slope (%)	N/A	N/A	DWS Full Width?	N/A		
N/A	Landing Curb? (Y/N)	N/A	N/A	DWS Offset (in)	N/A		
N/A	Shared Landing?	N/A					
N/A	Gutter Ponding?	N/A	N/A	Gutter Slope (%)	N/A		
N/A	Gutter Lip Ht (in)	N/A	N/A	Gutter X Slope (%)	N/A		
N/A	Painted X Walk1?	No	N/A	Painted X Walk2?	N/A		
	X Walk 1 Direction	То Е		X Walk 2 Direction	N/A		
N/A	X Walk 1 Width (in)	N/A	N/A	X Walk 2 Width (in)	N/A

X Walk 1 Slope (%)	0.3		X Walk 2 Slope (%)	N/A		
	X Walk 1 X Slope (%)	3.5		X Walk 2 X Slope (%)	N/A		
N/A	Ramp inside XWalk1?	N/A	N/A	Ramp inside XWalk2?	N/A		
	Road Slope (%)	N/A	N/A	Clear Space?	N/A		
	Road X Slope (%)	N/A	N/A	Clear Space to XWalk (in)	N/A		
N/A	Any Obstructions?	N/A	N/A	Storm Grate/Utility Hazard?	N/A		
	Obstruction Type			Storm Grate/Utility Type			
		N/A			N/A		
			Yes	Surface Condition? (G/P)	Good		
Te

Possible Solutions:	C
Remove & Replace Entire Ramp.	
	No
	N/
	N/
	N/
	N/
Surveyor Notes:	N/
N/A	N/
	N/
	N/
	N/
PROW/ADA:	N/
Not Found, R304.5.1, R304.5.3	N/
	N/
	N/
	N/
