Access Compliance Report Public Rights-of-Way (Curb Ramps)

Intersection ID: 50637 Main Street: RED_WATER_RD Cross Street: TOM_SHORT_RD Location: NW

ADA ID: 71D4205DEAD2 Ramp Type: Combination1 Initial Pass/Fail: Fail Overall Compliance: No Severity Score: 12.5

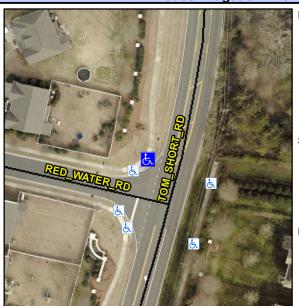
Possible Solutions:					
Remove & Replace Entire Ramp.					
Surveyor Notes:					
N/A					
N/A					
PROW/ADA:					
Not Found, R304.2.2, R304.3.2
