Access Compliance Report

Public Rights-of-Way

(Curb Ramps)

Intersection ID: 15267	Main Street: EAST_BV	Cross Street: FLORAL_AV	Location: SW
ADA ID: 71E86A538DF0	Ramp Type: Perp	Initial Pass/Fail: Fail	Overall Compliance: No
Severity Score: 37.5			
Codes/Mitigation Info/Possible Solution		Field Measurements/Component Compliance

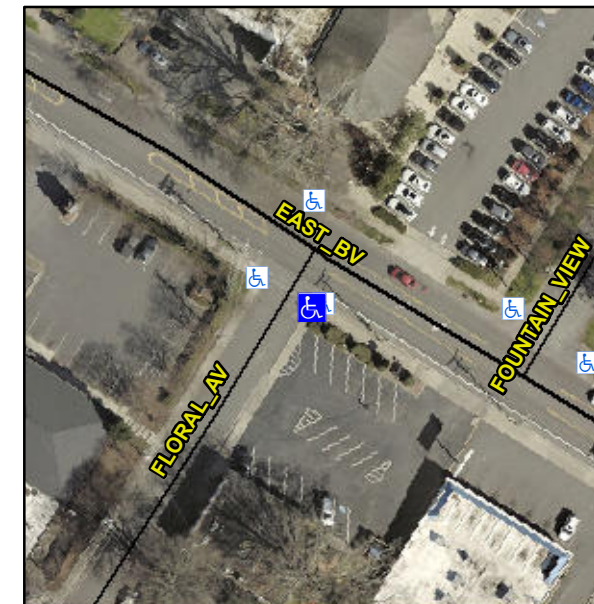
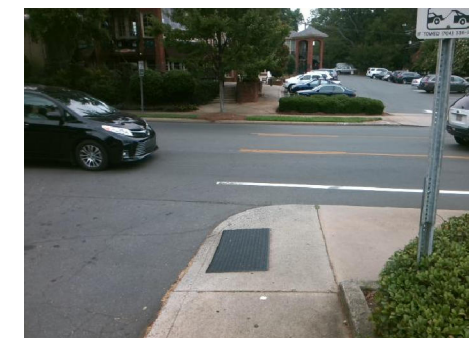
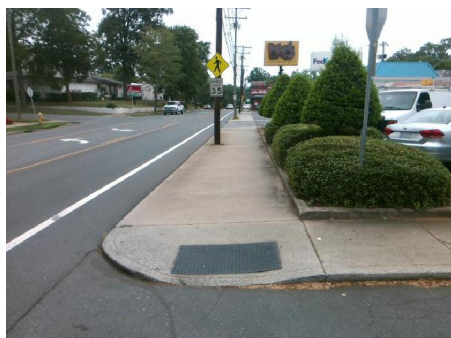
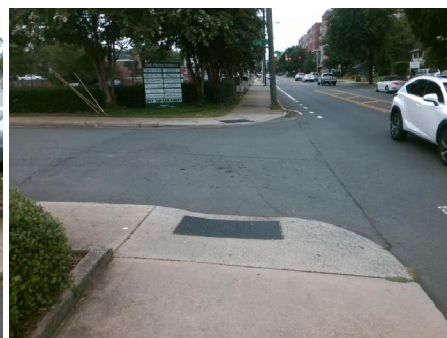
Not Found, R304.2.2, R304.5.3

Compliance	Description	Data	Compliance	Description	Data
N/A	Ramp Length (in)	60.0	No	Ramp Slope (%)	9.5
Yes	Ramp Width (in)	48.0	No	Ramp XSlope (%)	10.0
N/A	Flare Type LT	N/A	N/A	Flare Type RT	N/A
N/A	Flare Slope LT (%)	N/A	N/A	Flare Slope RT (%)	N/A
N/A	Flare Traversable LT?	N/A	N/A	Flare Traversable RT?	N/A
N/A	Landing Length (in)	N/A	N/A	DWS Provided?	N/A
N/A	Landing Width (in)	N/A	N/A	DWS Contrast?	N/A
N/A	Landing Slope (%)	N/A	N/A	DWS Length (in)	N/A
N/A	Landing X Slope (%)	N/A	N/A	DWS Full Width?	N/A
N/A	Landing Curb? (Y/N)	N/A	N/A	DWS Offset (in)	N/A
N/A	Shared Landing?	N/A			
N/A	Gutter Ponding?	N/A	N/A	Gutter Slope (%)	N/A
N/A	Gutter Lip Ht (in)	N/A	N/A	Gutter X Slope (%)	N/A
N/A	Painted X Walk1?	No	N/A	Painted X Walk2?	N/A
	X Walk 1 Direction	To NW		X Walk 2 Direction	N/A
N/A	X Walk 1 Width (in)	N/A	N/A	X Walk 2 Width (in)	N/A
	X Walk 1 Slope (%)	6.3		X Walk 2 Slope (%)	N/A
	X Walk 1 X Slope (%)	2.8		X Walk 2 X Slope (%)	N/A

N/A	Ramp inside XWalk1?	N/A	N/A	Ramp inside XWalk2?	N/A
	Road Slope (%)	N/A	N/A	Clear Space?	N/A
	Road X Slope (%)	N/A	N/A	Clear Space to XWalk (in)	N/A
N/A	Any Obstructions?	N/A	N/A	Storm Grate/Utility Hazard?	N/A
	Obstruction Type			Storm Grate/Utility Type	
		N/A			N/A
		Yes		Surface Condition? (G/P)	Good

Remove & Replace Entire Ramp.
