Access Compliance Report

Public Rights-of-Way

(Curb Ramps)

Intersection ID: 10014838		Main Street: THE_PLAZA		Cross Street: N/A		Location:		SE	
ADA ID: 71F8C68F8A48		Ramp Type: Combination2		Initial Pass/Fail: Pass		Overall Compliance: No		Severity Score: 0.25	
Codes/Mitigation Info/Possible Solution				Field Measurements/Component Compliance

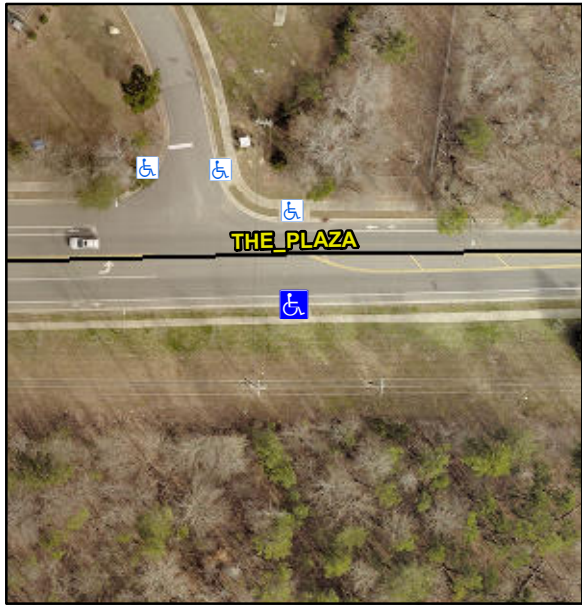
Possible Solutions:		Compliance	Description	Data	Compliance	Description	Data
		Remove & Replace Entire Ramp.		N/A	Ramp Length LT (in)	72.0	N/A	Ramp Length RT (in)	N/A
		Remove & Replace Gutter.		Yes	Ramp Width LT (in)	60.0	N/A	Ramp Width RT (in)	N/A
				Yes	Ramp Slope LT (%)	6.6	N/A	Ramp Slope RT (%)	N/A
				No	Ramp XSlope LT (%)	2.2	N/A	Ramp XSlope RT (%)	N/A
				N/A	Ramp Length (in)	48.0	Yes	Ramp Slope (%)	5.9
				Yes	Ramp Width (in)	48.0	Yes	Ramp XSlope (%)	1.6
		Surveyor Notes:		N/A	Flare Type LT	Sloped	N/A	Flare Type RT	Sloped
		N/A		N/A	Flare Slope LT (%)	9.6	N/A	Flare Slope RT (%)	4.6
				N/A	Flare Traversable LT?	No	N/A	Flare Traversable RT?	No

PROW/ADA:		Yes	Landing Length (in)	60.0	Yes	DWS Provided?	Yes
				Yes	Landing Width (in)	48.0	Yes	DWS Contrast?	Yes
		Not Found, R304.5.3, R304.2.2-Perp, R304.3.2-Para		No	Landing Slope (%)	6.4	Yes	DWS Length (in)	24.0
				No	Landing X Slope (%)	2.7	Yes	DWS Full Width?	Yes
				N/A	Landing Curb? (Y/N)	No	Yes	DWS Offset (in)	0.0
				N/A	Shared Landing?	No			
				Yes	Gutter Ponding?	No	Yes	Gutter Slope (%)	4.9
				Yes	Gutter Lip Ht (in)	0.0	No	Gutter X Slope (%)	2.6
				N/A	Painted X Walk1?	No	N/A	Painted X Walk2?	N/A
					X Walk 1 Direction	To N		X Walk 2 Direction	N/A
Street 1 Name		None			X Walk 1 Width (in)	N/A		X Walk 2 Width (in)	N/A
Stop Condition-Street 1		THE PLAZA			X Walk 1 Slope (%)	3.5		X Walk 2 Slope (%)	N/A
Street 2 Name		N/A			X Walk 1 X Slope (%)	1.4		X Walk 2 X Slope (%)	N/A
Stop Condition-Street 2		N/A			Ramp inside XWalk1?	N/A	N/A	Ramp inside XWalk2?	N/A
					Road Slope (%)	N/A		Clear Space?	Yes

Road X Slope (%)	N/A	N/A	Clear Space to XWalk (in)	N/A
							Yes	Any Obstruction?	No
								Obstruction Type	N/A
							Yes	Storm Grate/Utility Hazard?	No
								Storm Grate/Utility Type	N/A
							Yes	Surface Condition? (G/P)	Good
								Curb Slope (%)	11.5
		Total Cost:		\$	2350.00
