# Access Compliance Report

## Public Rights-of-Way

| Intersection ID: 14014 | Main Street: N_SHARON_AMITY_RD | Cross Street: WILORA_LAKE_RD | Location: SE |
| ADA ID: 71F8D0279EB0 | Ramp Type: Perp | Initial Pass/Fail: Fail | Overall Compliance: No |

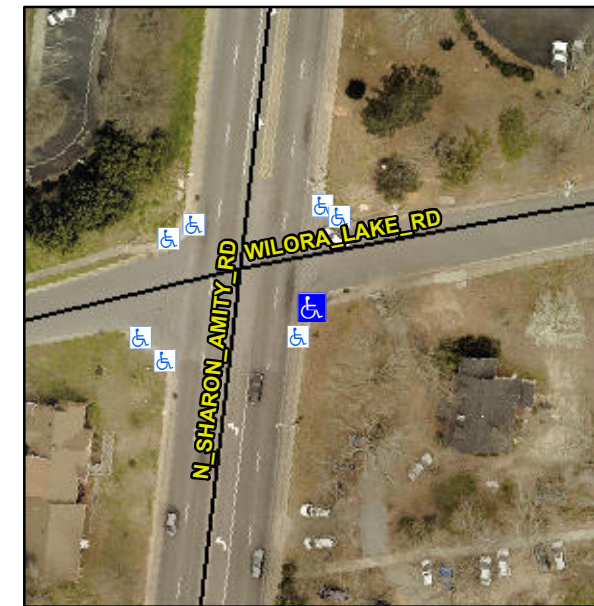
| | | Severity Score: 12.5 | |

**Not Found, R304.2.2**

| Compliance | Description | Data | Compliance | Description | Data |
|---|---|---|---|---|---|
| N/A | Ramp Length (in) | 60.0 | No | Ramp Slope (%) | 10.2 |

**Remove & Replace Entire Ramp.**

Total Cost: \$ 1850.00
