# Access Compliance Report

## Public Rights-of-Way

### (Curb Ramps)

Intersection ID: N/A	Main Street: REDSPIRE DR	Cross Street: N/A	Location: NW
ADA ID: 71F96D8D0890	Ramp Type: Perp	Initial Pass/Fail: Fail	Overall Compliance: No
Severity Score: 22.5			
Codes/Mitigation Info/Possible Solution		Field Measurements/Component Compliance

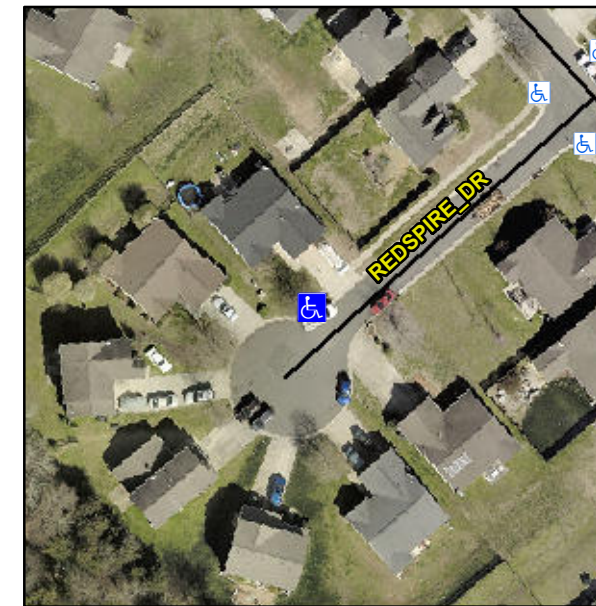
Compliance	Description	Data	Compliance	Description	Data
N/A	Ramp Length (in)	51.0	No	Ramp Slope (%)	9.3
No	Ramp Width (in)	46.5	Yes	Ramp XSlope (%)	4.0
N/A	Flare Type LT	N/A	N/A	Flare Type RT	N/A
N/A	Flare Slope LT (%)	N/A	N/A	Flare Slope RT (%)	N/A
N/A	Flare Traversable LT?	N/A	N/A	Flare Traversable RT?	N/A
N/A	Landing Length (in)	N/A	N/A	DWS Provided?	N/A
N/A	Landing Width (in)	N/A	N/A	DWS Contrast?	N/A
N/A	Landing Slope (%)	N/A	N/A	DWS Length (in)	N/A
N/A	Landing X Slope (%)	N/A	N/A	DWS Full Width?	N/A
N/A	Landing Curb? (Y/N)	N/A	N/A	DWS Offset (in)	N/A
N/A	Shared Landing?	N/A			
N/A	Gutter Ponding?	N/A	N/A	Gutter Slope (%)	N/A
N/A	Gutter Lip Ht (in)	N/A	N/A	Gutter X Slope (%)	N/A
N/A	Painted X Walk1?	No	N/A	Painted X Walk2?	N/A
	X Walk 1 Direction	To SE		X Walk 2 Direction	N/A
N/A	X Walk 1 Width (in)	N/A	N/A	X Walk 2 Width (in)	N/A
	X Walk 1 Slope (%)	3.8		X Walk 2 Slope (%)	N/A
	X Walk 1 X Slope (%)	5.8		X Walk 2 X Slope (%)	N/A

N/A	Ramp inside XWalk1?	N/A	N/A	Ramp inside XWalk2?	N/A
	Road Slope (%)	N/A	N/A	Clear Space?	N/A
	Road X Slope (%)	N/A	N/A	Clear Space to XWalk (in)	N/A
N/A	Any Obstructions?	N/A	N/A	Storm Grate/Utility Hazard?	N/A
	Obstruction Type			Storm Grate/Utility Type	
		N/A			N/A
			Yes	Surface Condition? (G/P)	Good

Possible Solutions:

**Remove & Replace Entire Ramp.**

**R304.5.1, R304.2.2**

Total Cost: \$ 1850.00
